Innovative Remediation Techniques to Compressor Foundation Systems

12th Conference of the EFRC
August 24-26, 2021, Warsaw, Poland

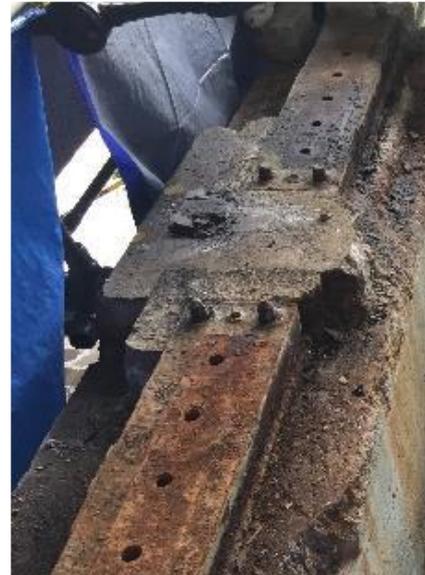
Removal of the existing sole plates and the damaged cementitious grout was performed. Please see Figure 2, Figure 3, & Figure 4 for detail on the initial condition and removal of the previously installed transfer medium.

Figure 2: Removal of Existing Cementitious Grout

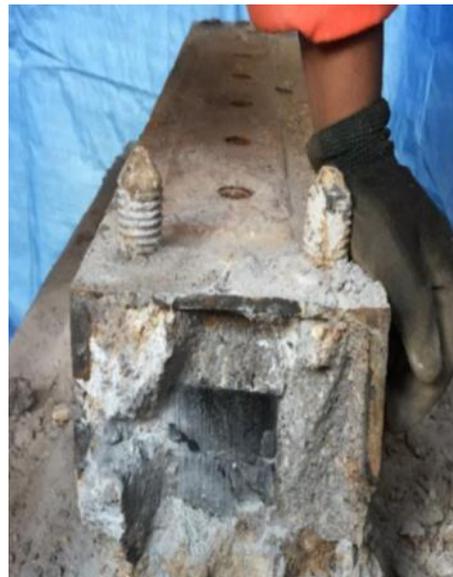
The compressor was originally installed in 1978. When installed originally, the foundation was mounted on a cementitious grout. Over time, the vibrations resulting from the operation of the compressor steadily increased. This resulted in extensive mechanical damage to the compressor, as well as damage to the foundation system. Initial efforts were made to ensure the proper tensioning of the anchor bolts, but the bolts kept relaxing over time. The vibrations eventually increased to the point that the equipment could no longer be operated due safety concerns.

Figure 3: Degradation of Existing Cementitious Grout under Support Rails

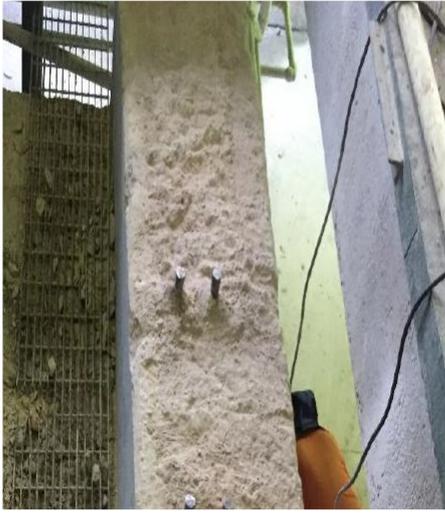
Figure 4: Surface of Concrete after removal of Cementitious Grout and Support Rails

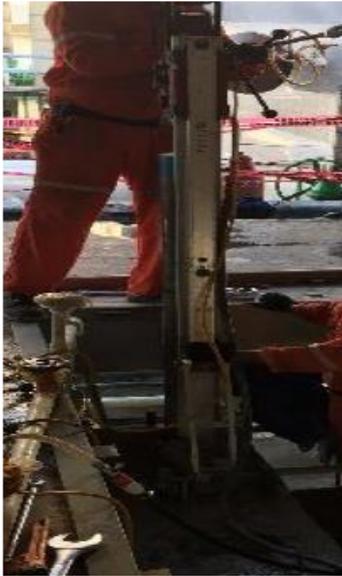
Figure 5: Core Drilling Damaged Anchor Bolts

This step also included removal of the anchor bolts using a core drill. Core drilling was performed using a 6" OD core drill bit and were drilled down to a depth of 1000 mm, to accommodate the new bolts with a length of 950 mm. Please see Figure 5 & Figure 6 for details on the removal process of the anchor bolts and the foundation after core drilling was completed.

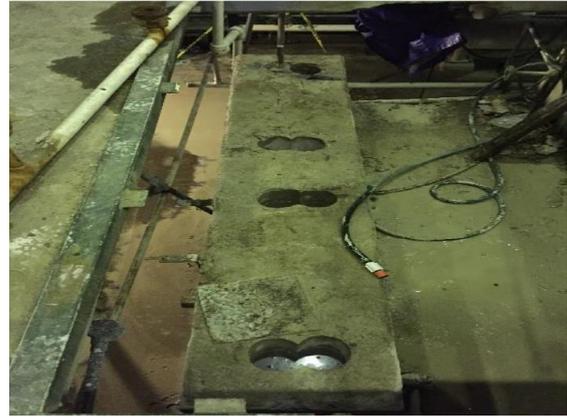
Figure 6: Foundation After Damaged Anchor Bolts Removed

A total of 4 support rails and 16 damaged bolts were removed under the compressor. The core drilling of the anchor bolts also allowed access for further inspection of the cracks within the concrete foundation, as well as the overall integrity of the concrete block.

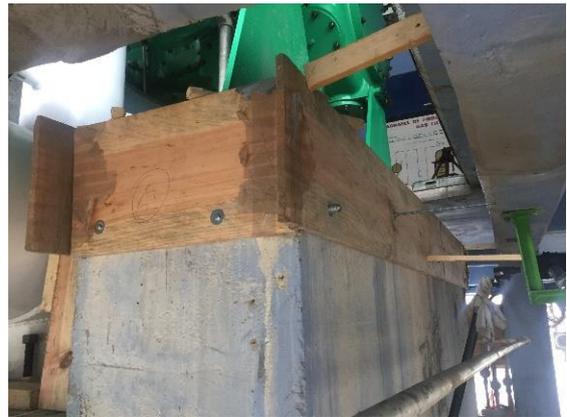
Figure 7: Formwork for Mounting Support Rails on Epoxy Grout

After delivery of the new anchor bolts was completed, the final portion of the foundation overhaul could be completed. The new anchor bolts were Class 8.8 per ISO 898-1. After ensuring that the anchor bolts were cleaned, the compressor was aligned, and the anchor bolts were hung into the newly drilled anchor bolt pockets. Formwork was constructed to allow filling of the mounting area. The mounting area under the compressor support rails were filled with a superior epoxy grout, as recommended and installed by the regional foundation expert team. Please see Figure 7 & Figure 8 for preparation and pouring of the epoxy grout under the compressor.

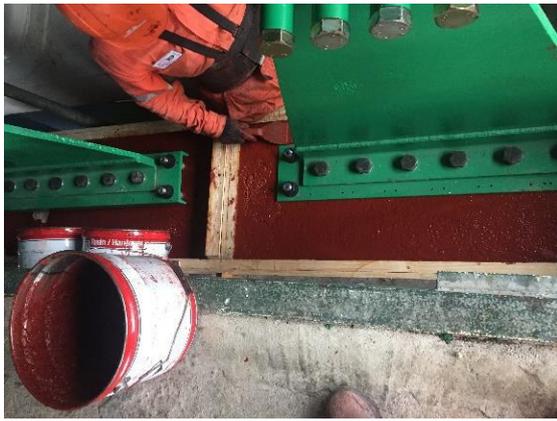
Figure 8: Superior Epoxy Grout Installed Under Compressor Support Rails

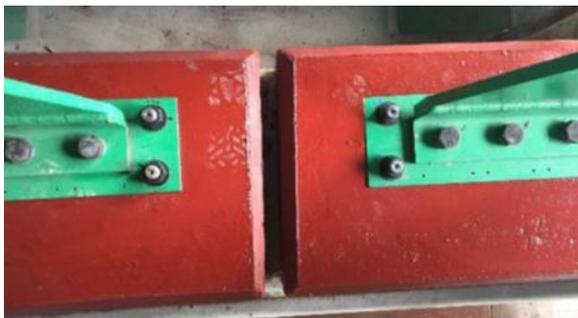
Figure 9: Final View of Compressor Support Rails on Superior Epoxy Grout

After sufficient time had elapsed, as advised per the recommendations of the epoxy grout manufacturer, the formwork was removed, the removable alignment devices were backed out, and the anchor bolts were properly tensioned per the recommendations of the OEM. Please see Figure 9 for a view of the final mounting of the compressor.

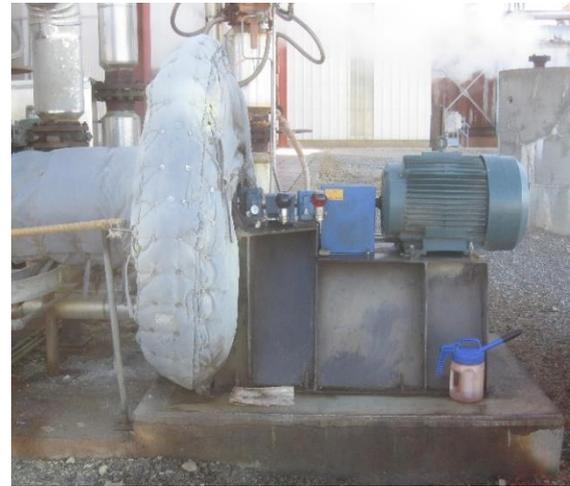
The equipment was originally installed approximately three decades prior to the decision to perform the remediation. Epoxy grout was used in the initial installation and maintained its integrity. The epoxy grout encapsulated the entire top of concrete foundation block, which extended beyond the footprint of the steel baseplate approximately 300 mm (Please see Figure 10). Due to the exposure of the foundation system to the harsh environmental elements, including extreme temperature changes, edge lifting occurred within the concrete below the bond line with the epoxy grout (Please see Figure 11).

Figure 10: Original Equipment Installation

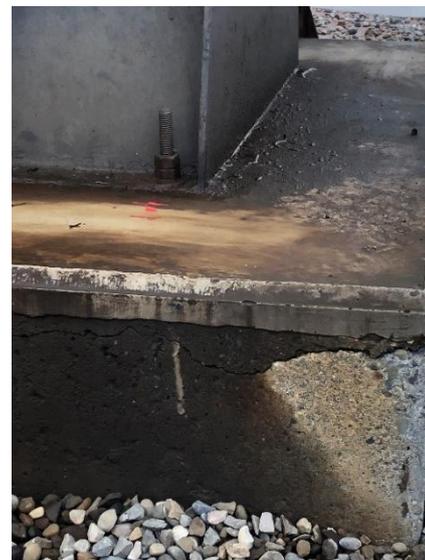
Figure 11: Edge Lifting on Foundation

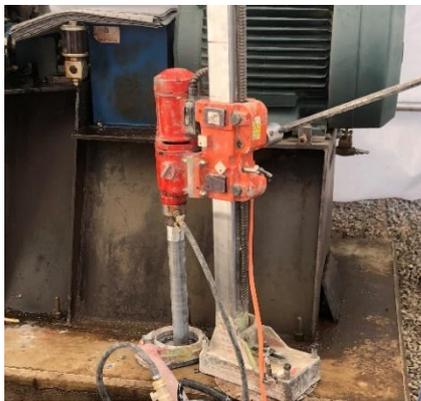
Figure 12: Core Drilling New Anchor Bolt Pockets

The first step was to core drill new anchor bolt pockets through the epoxy grout and into the concrete foundation. The new pockets were approximately 300 mm into the existing concrete foundation. Please see Figure 12 showing the core drilling operation.

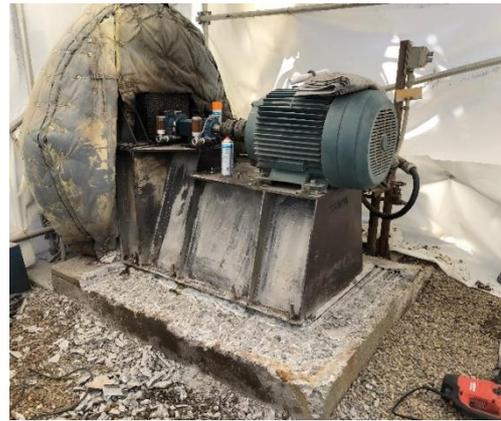
Figure 13: In-Process of Removal of Existing Epoxy Grout and Underlying Concrete

After adding the anchor bolt pockets, hand-held pneumatic chipping guns were used to remove as much of the existing epoxy grout as possible. This was performed to the extent possible by the reach of tooling and kept in place most of the original epoxy grout under the center of the equipment. This also allowed the equipment alignment to be maintained without requiring temporary supports. Existing epoxy grout and underlying concrete were removed until clean and sound concrete was reached and prepared per best practices for installation of a superior epoxy grout. Additionally, the edges and corners of the foundation were chamfered to help minimize the potential for edge lifting to occur in the future. Please see Figure 13

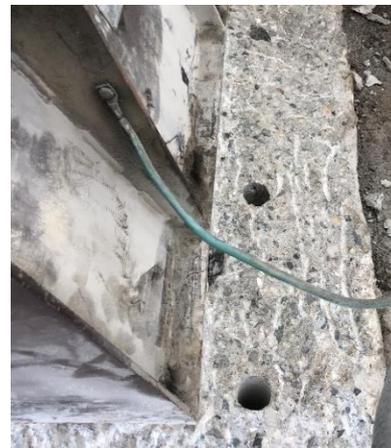
Figure 14: New Anchor Bolt Pockets in Properly Prepared Concrete Surface

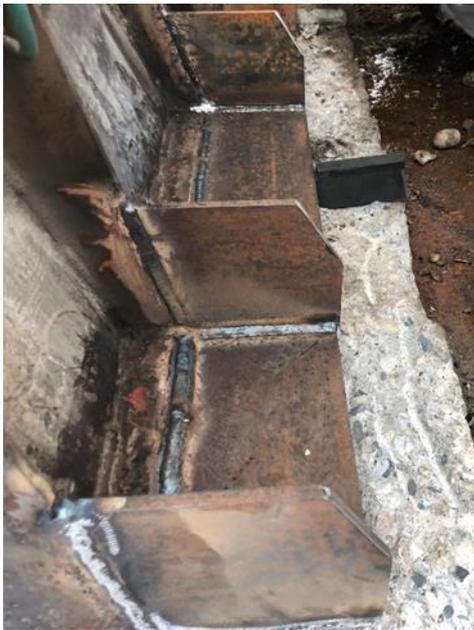
Figure 15: Baseplate Extension Welded to Existing Baseplate

After the surfaces were properly prepared, the formerly used anchor bolts were cut flush with the existing baseplate. In this position, they could not be tensioned and would reduce confusion for future maintenance activities. The newly manufactured baseplate extension was welded to the existing baseplate, as shown in Figure 15.

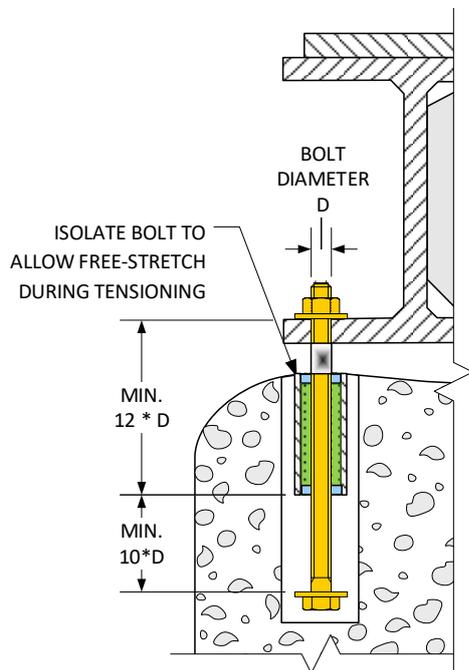
New ASTM A193 B7 anchor bolts were installed in the baseplate extension and hung in the anchor bolt pockets. It was ensured that the new anchor bolts featured recommend free-stretch length, as shown in Figure 16. The original bolts did not have this free-stretch length, and it is thought that this is the primary reason why the bolts failed prematurely.

Figure 16: Proper Anchor Bolting Configuration

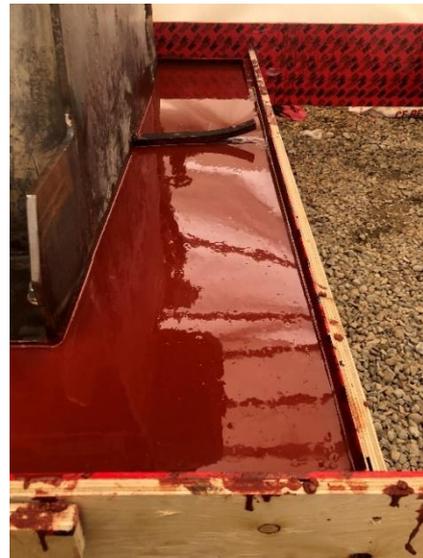
Figure 17: Superior Epoxy Grout Installed in New Anchor Bolt Pockets and Under Baseplate and Baseplate Extension

A superior quality epoxy grout was poured in the anchor bolt pockets and under the baseplate. The entire original epoxy grout cap was encapsulated within the new, superior epoxy grout cap. Control joints were used to segment the pour and allow for expansion and contraction of the epoxy grout due to thermal changes.

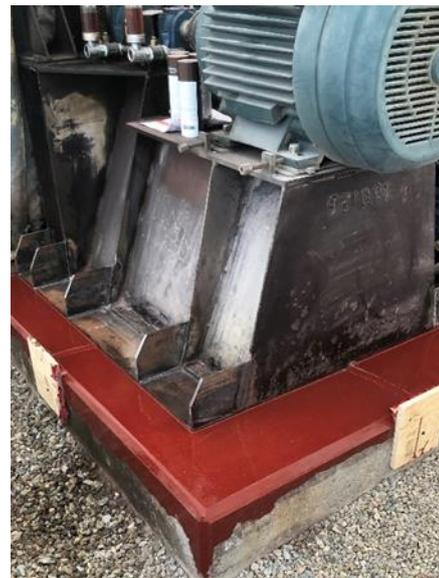
Figure 18: Final View of the Equipment Remediation

After sufficient time had elapsed, as advised per the epoxy grout manufacturer, the formwork was removed, and the anchor bolts were properly tensioned.
