53RD TURBOMACHINERY & 40TH PUMP SYMPOSIA
AUGUST 19 - 22, 2024 | HOUSTON, TX | GEORGE R. BROWN CONVENTION CENTER

Existing Compressor Skid Vibration: Anchoring & Grouting Upgrade

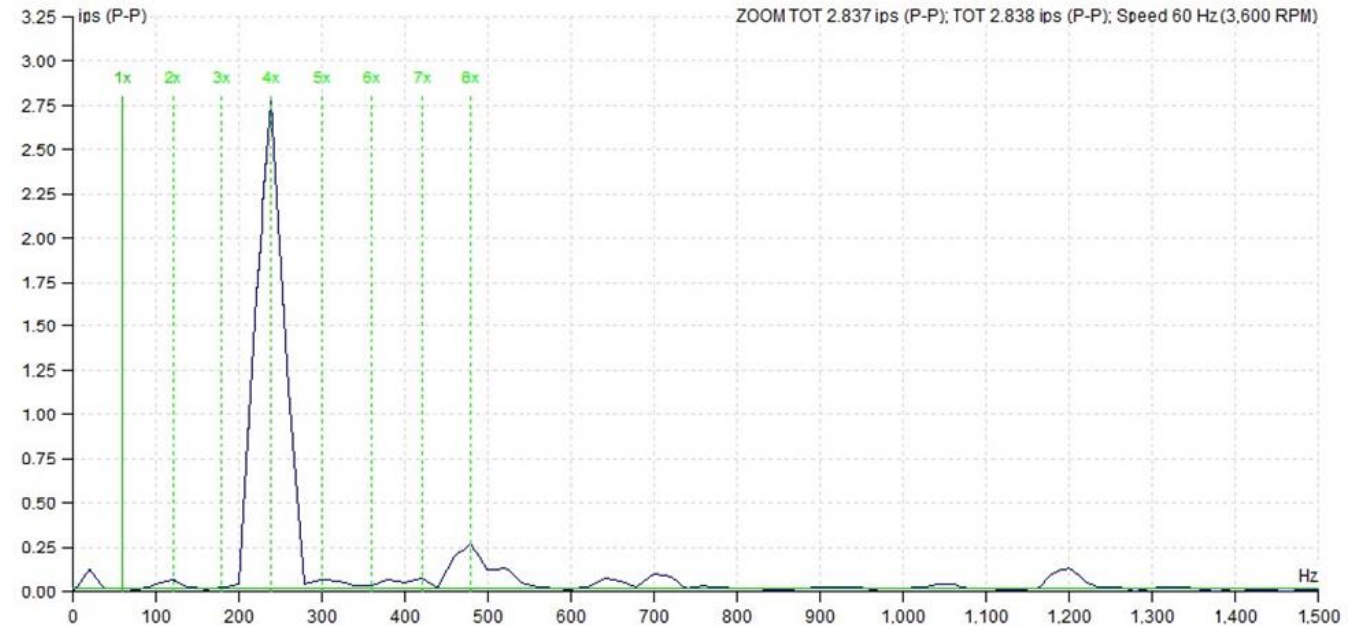
- High vibrations during operation measured on frame, compressor, coalescer vessel, & motor
 - Bordering the realm of compressor degradation
 - Data collected with continuous casing vibration monitor in conjunction with structure analyzed with a handheld vibration meter.
 - High readings trigger engineering alert.

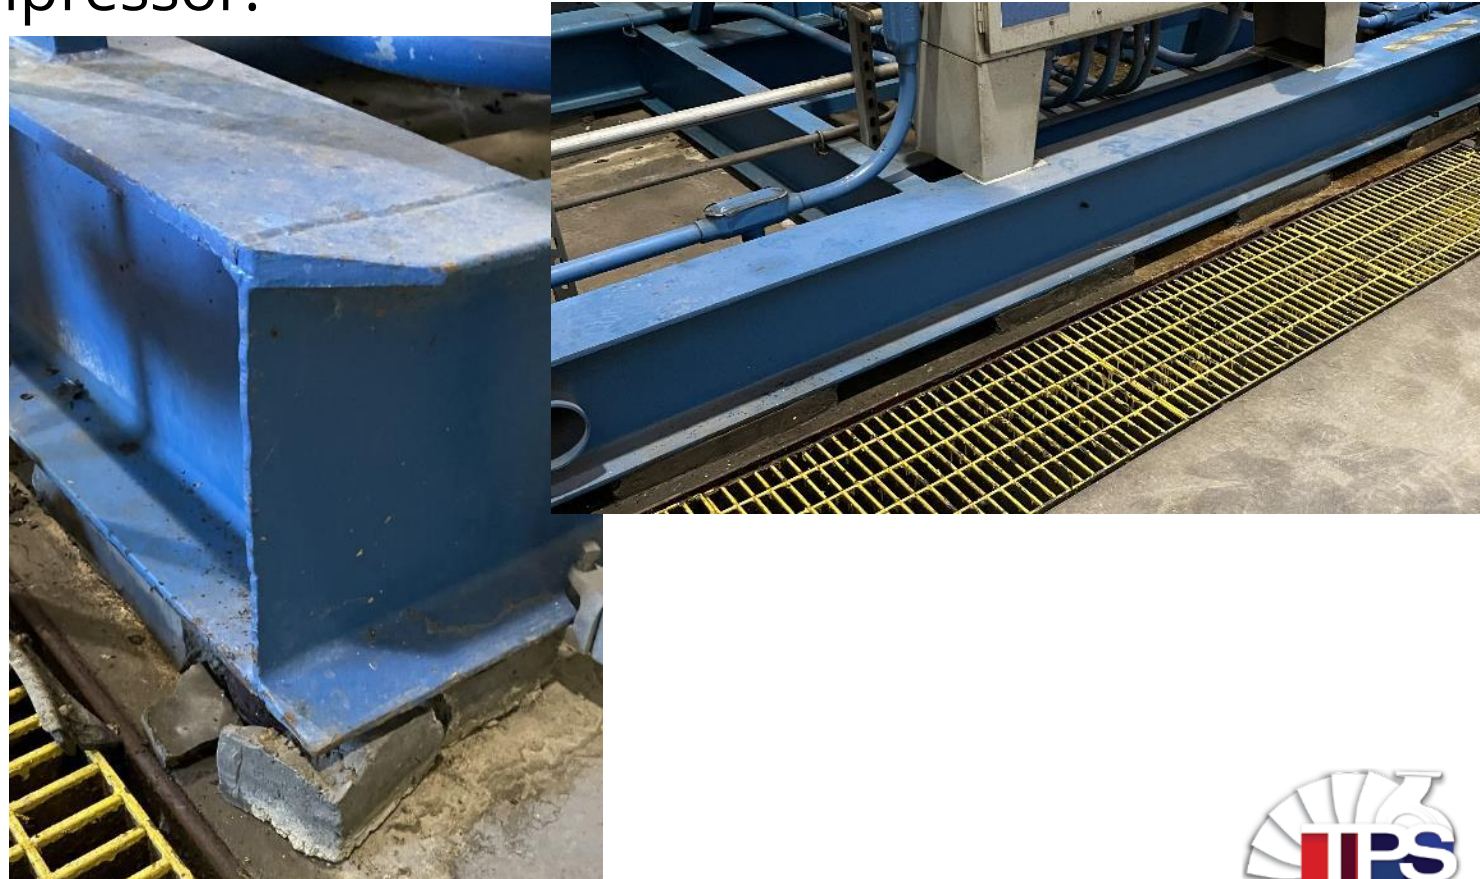
- Handheld spectral analysis
 - Frequency spectrums confirmed vibration source to be gas pulse frequency of the compressor.
- No anchor bolts or other connection devices between foundation and skid
- Minimal cementitious grout under perimeter beams
- Compressor and driver loads on interior beams

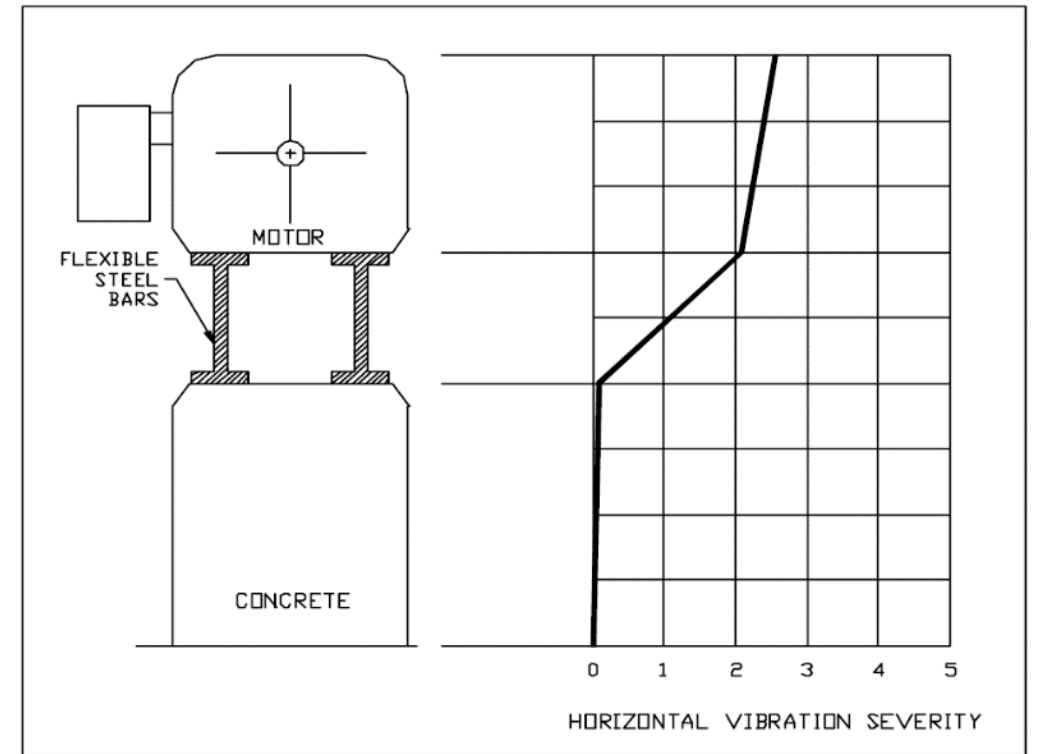
Plot of Vibration (in mils) vs. Base/Motor Position for a Weak Motor Base¹

- Followed up with site visit
- Used handheld vibration monitor looked at frame and skid vibrations
 - Expected to see vibrations decrease as distance increased from vibration source
 - Measured higher vibrations as moving away from the compressor
 - Evidence of amplification and improper skid stiffness
 - Referenced OEM Motor Vibration guidelines

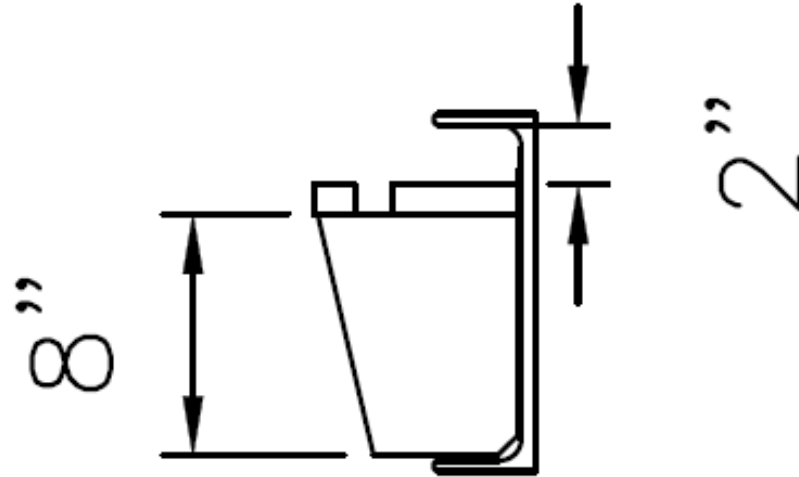
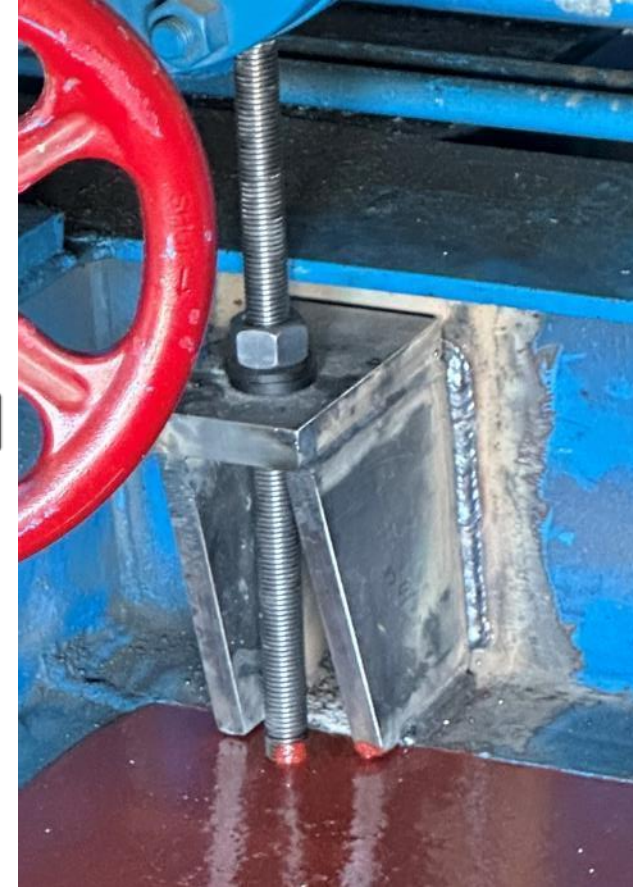
- To achieve effective anchor bolt stretch, anchor bolt chairs to be welded to the existing compressor skid frame.
- Standard chemical anchors used to secure bolts to the existing concrete foundation.

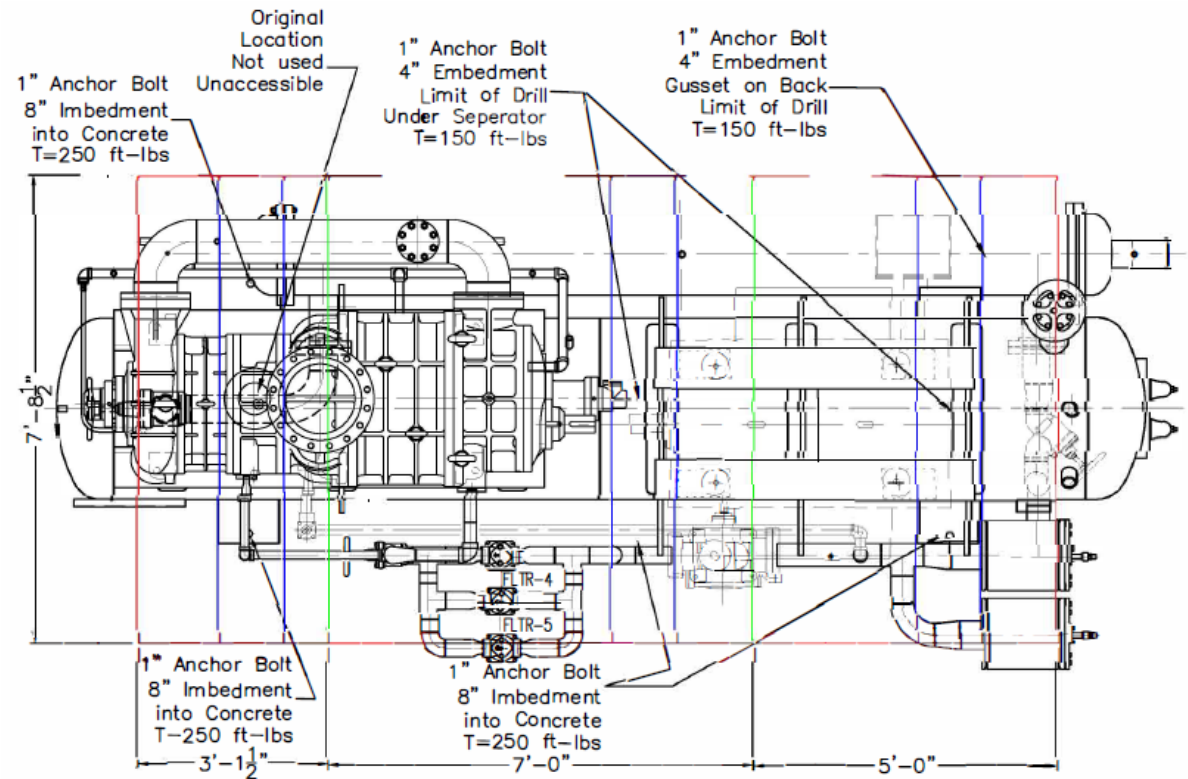
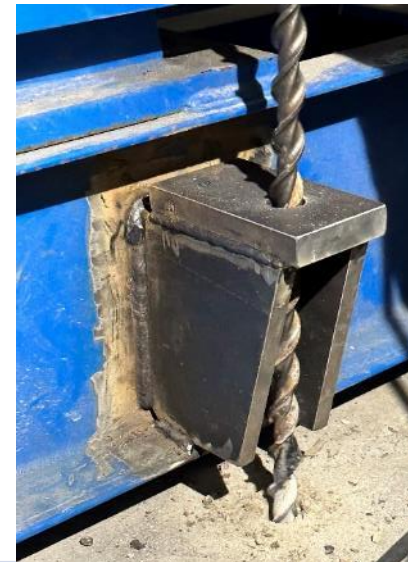
- Drill anchor bolt holes as deep as possible
 - 1-1/8" OD hole for a 1" OD chemical anchor
 - Unable to achieve goal 8-in (203-mm) embedment for all anchors
- Weld anchor chairs to skid frame
 - Hang new anchors from chairs until and apply chemical anchors

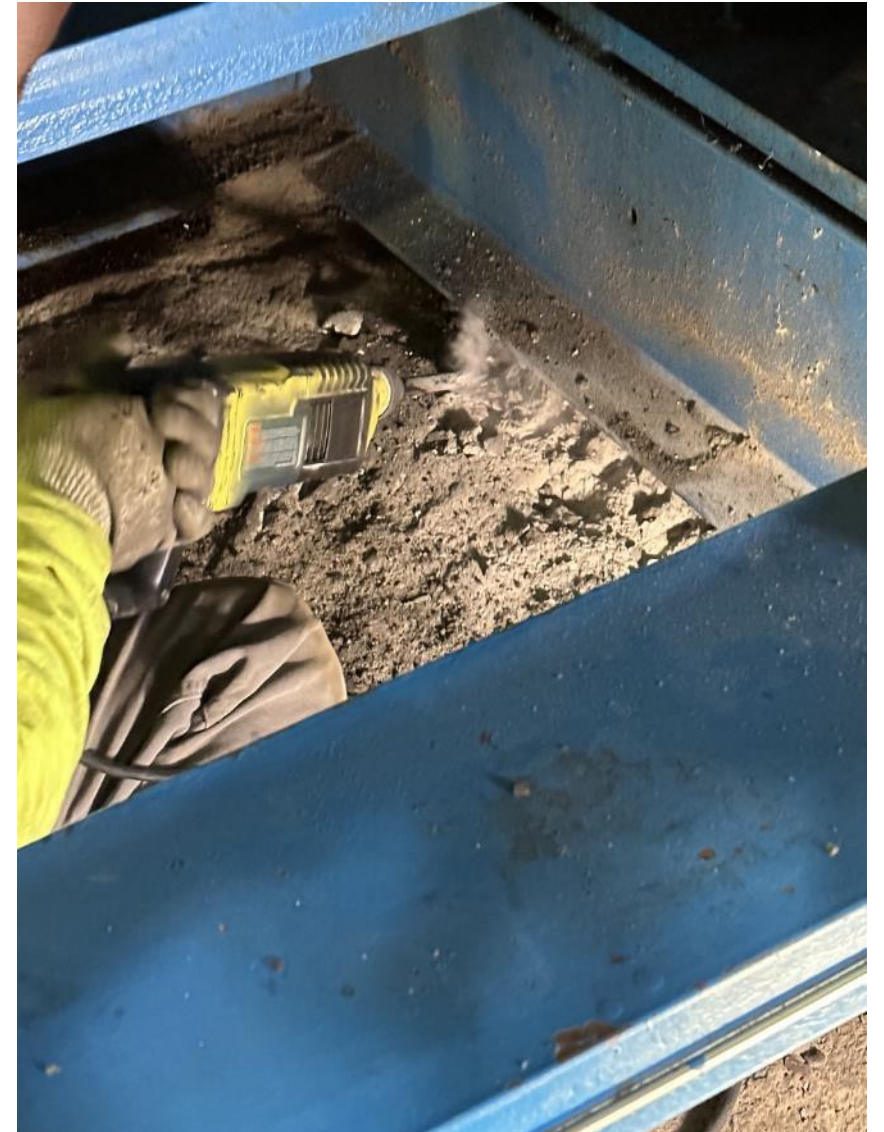
- Initial pressure wash and degreasing of frame
- Prepare concrete surfaces
 - Focused on beam-loaded areas
- Clean steel frame surfaces
- Install control joints

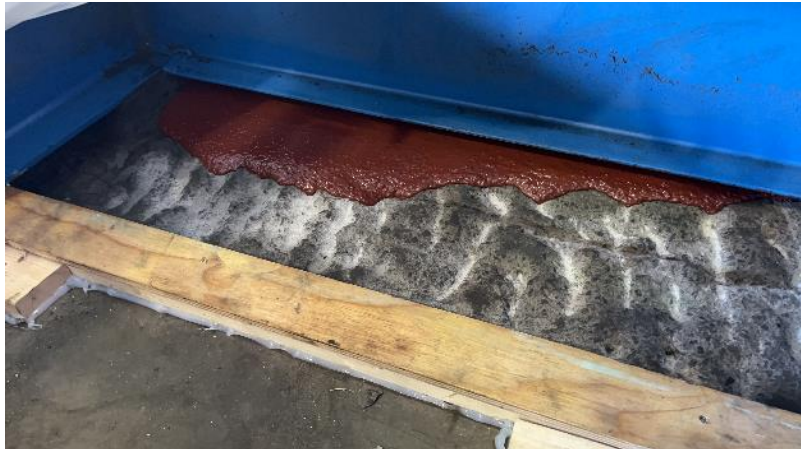
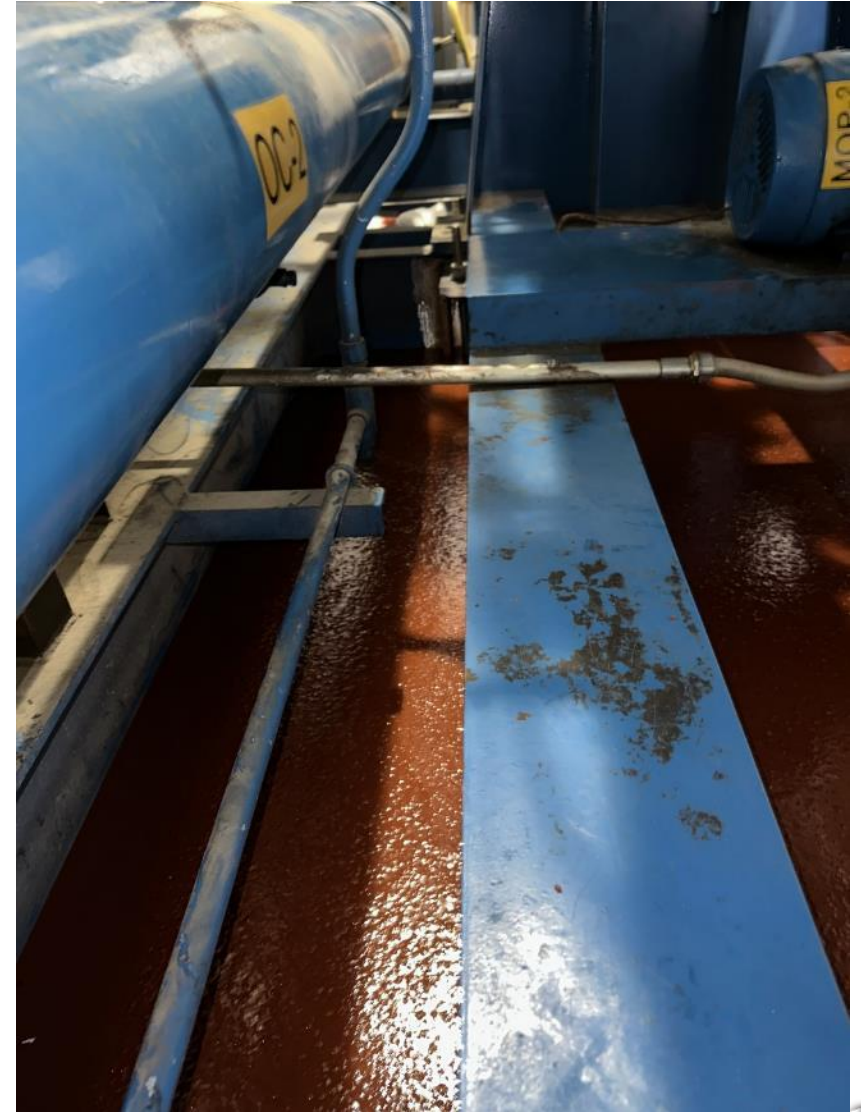
- Mix and pour best-in-class epoxy grout under primary load areas and structural frame
- Allow epoxy grout to cure

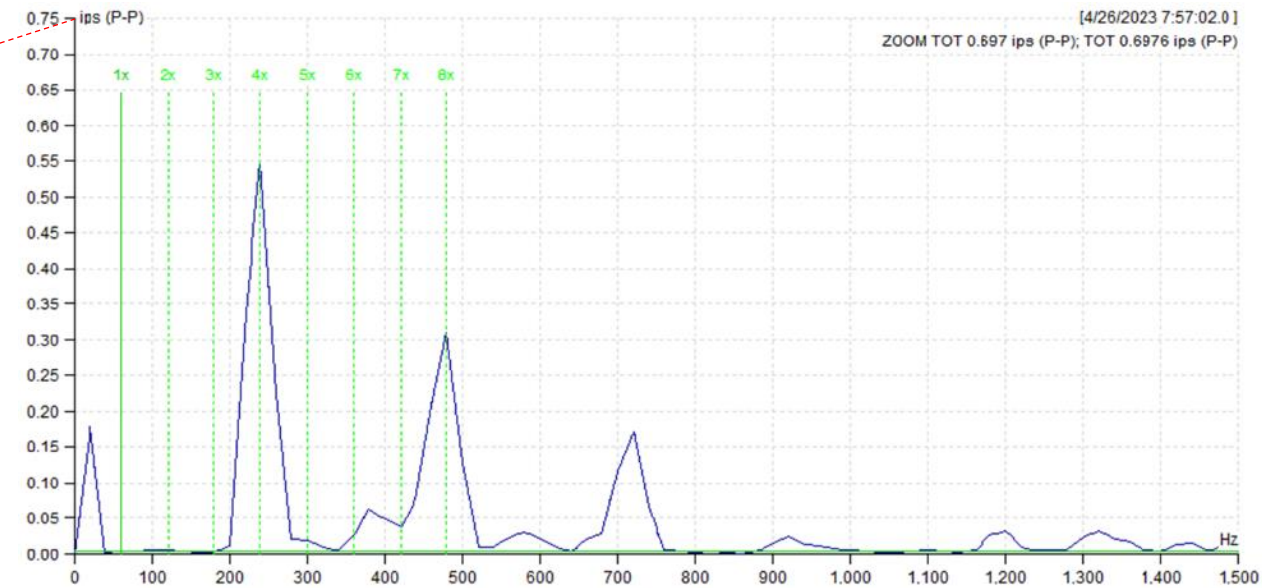
Frame Vibrations Measured after Intervention

- Frame vibrations were re-evaluated post-grouting, indicating a substantial reduction.
- Considered a success due to:
 - Install execution
 - Vibration reduction
 - Conformance to current installation standards

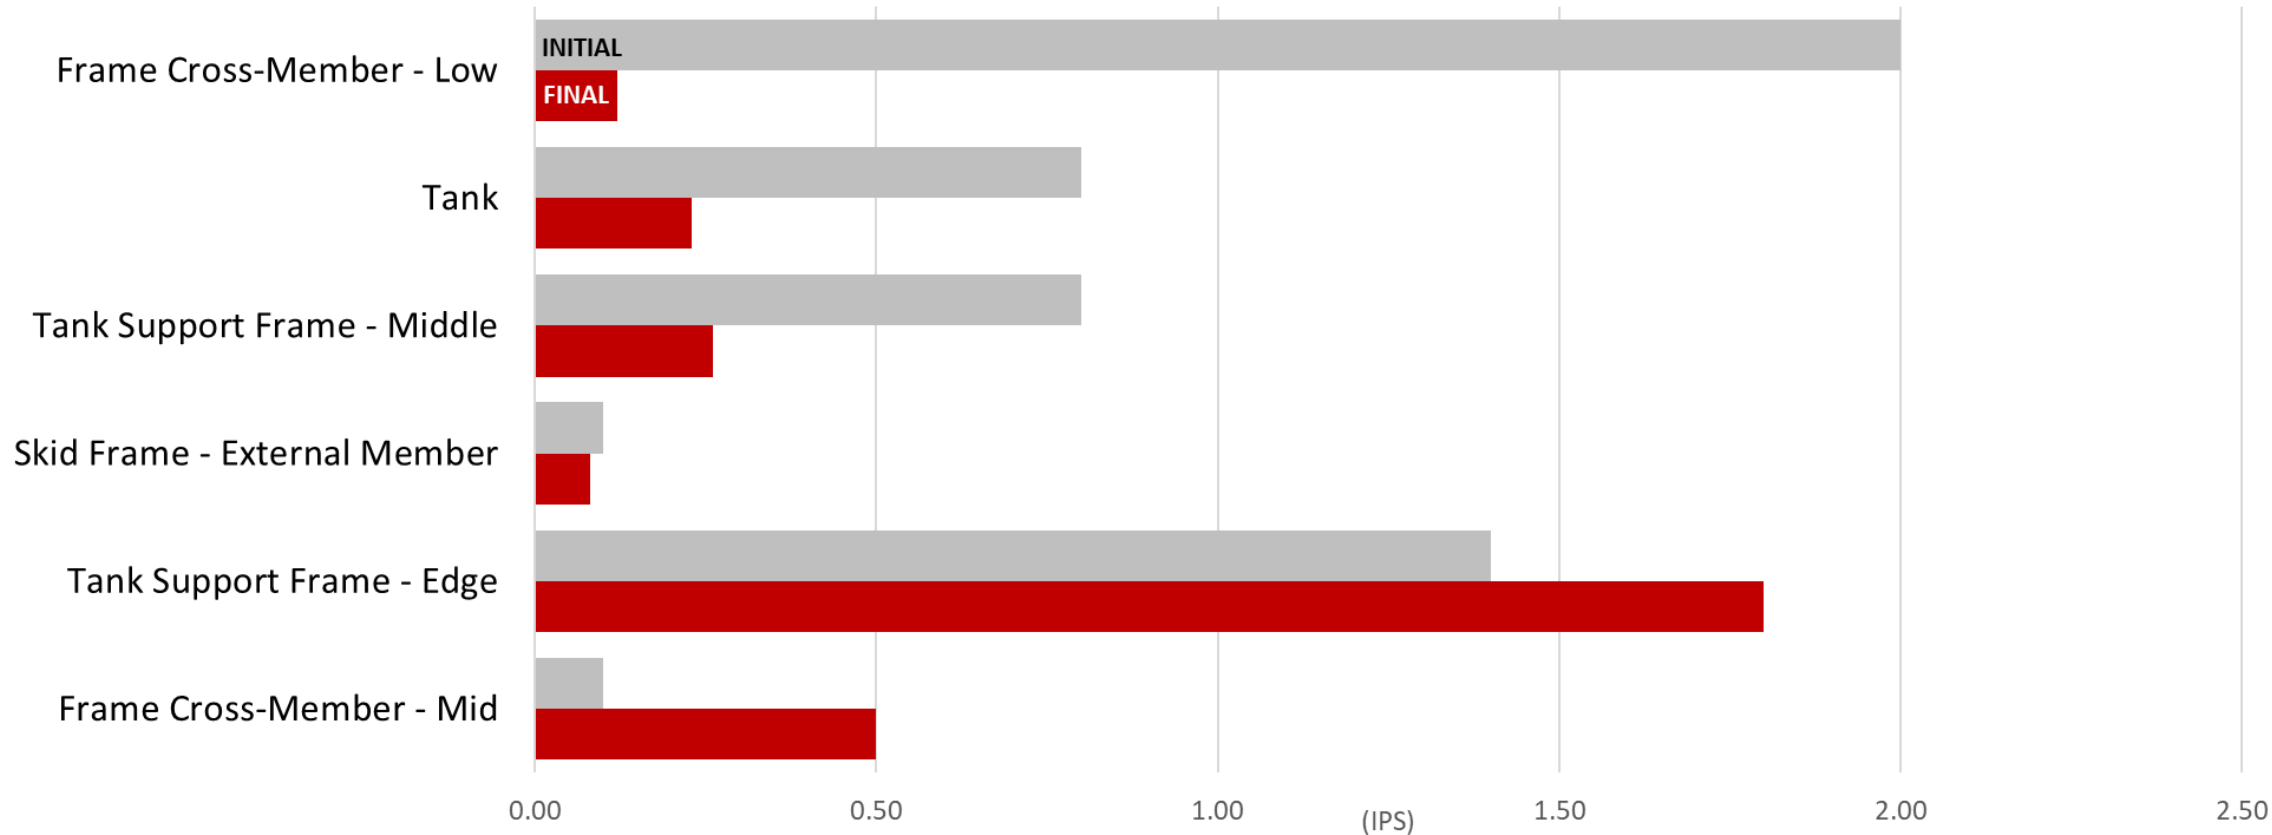
Overall Reduction

Comparing vibrations before and after intervention at key locations
