**12th EFRC Conference, Warsaw, Poland**  
August 24-26, 2021

# **Innovative Remediation Techniques to Compressor Foundation Systems**

# Case History – Equipment Removal and Foundation Rework

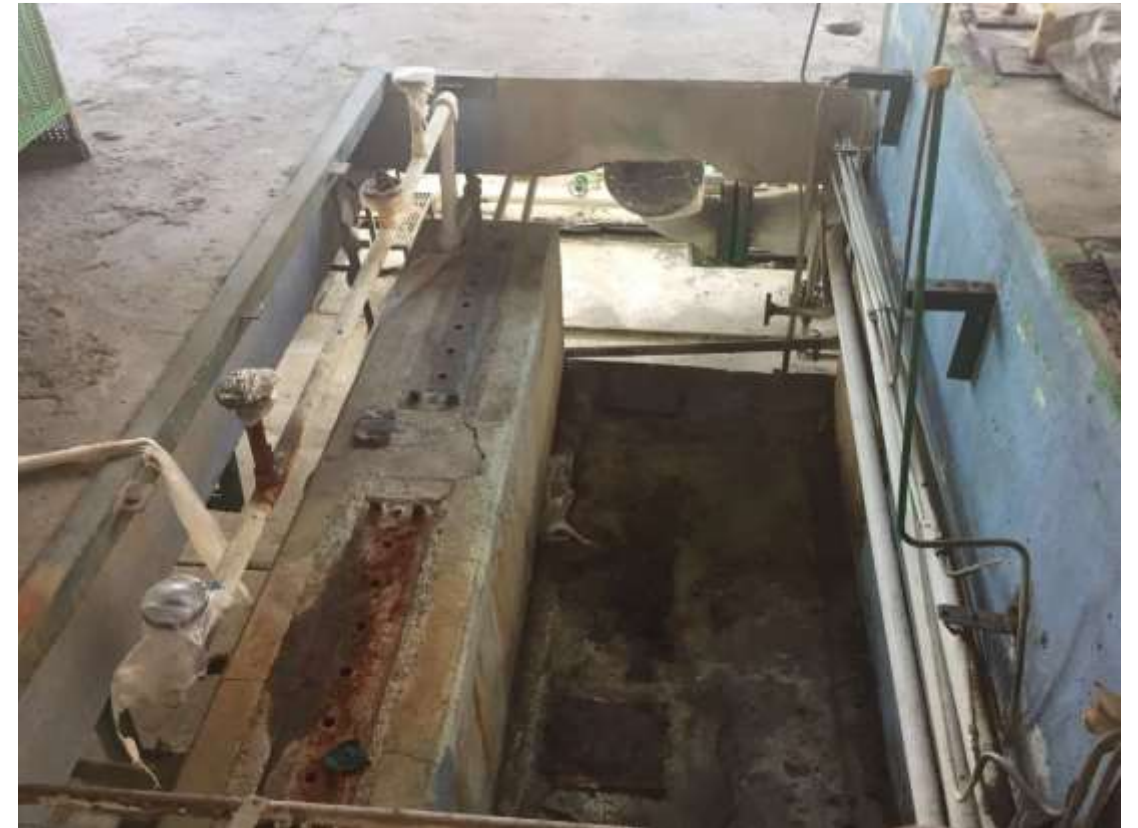
- A major operator of a petrochemical facility was experiencing ongoing performance and mechanical problems with a critical, one-stage, 4-cylinder reciprocating process gas compressor.
- Originally installed in 1978 on cementitious grout.
- Overtime, vibrations increased to the point that the equipment could no longer be operated due to safety concerns.

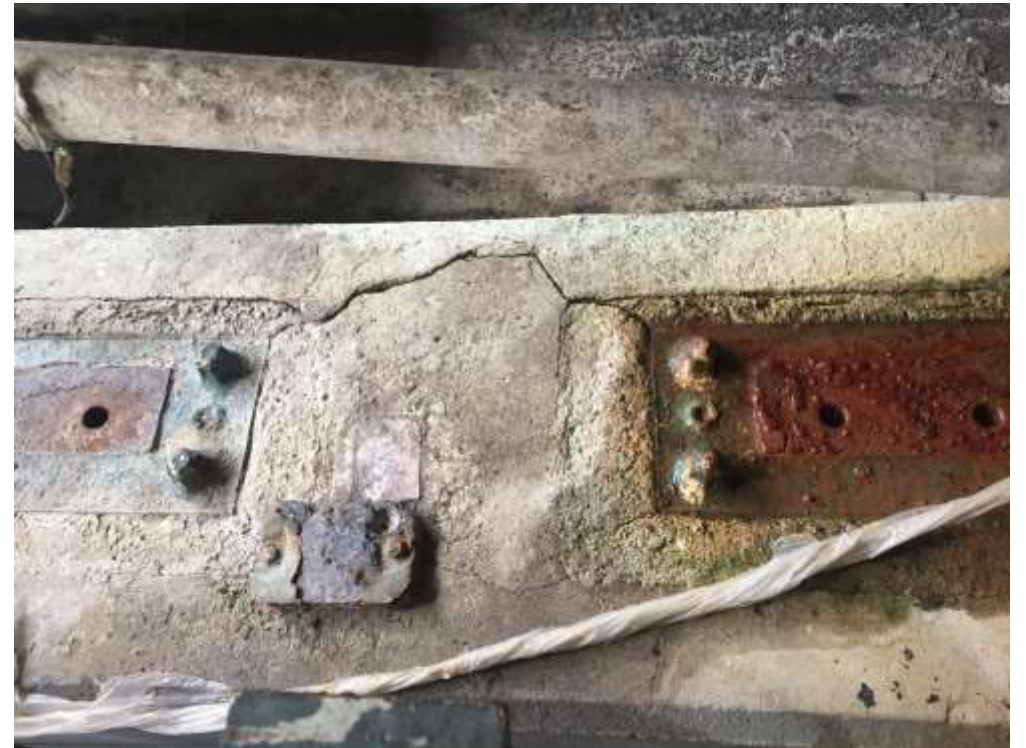
- Asset owner contracted the original equipment manufacturer (OEM) to review, diagnose, and implement remediation.
- OEM partnered with a regional team of foundation experts to assess extent of damage and develop remediation plan.
- Vibrations resulted in extensive damage to foundation system.
  - Mechanical Damage to Compressor Components
  - Anchor Bolts no longer maintaining tension
  - Extensive cracks within foundation system

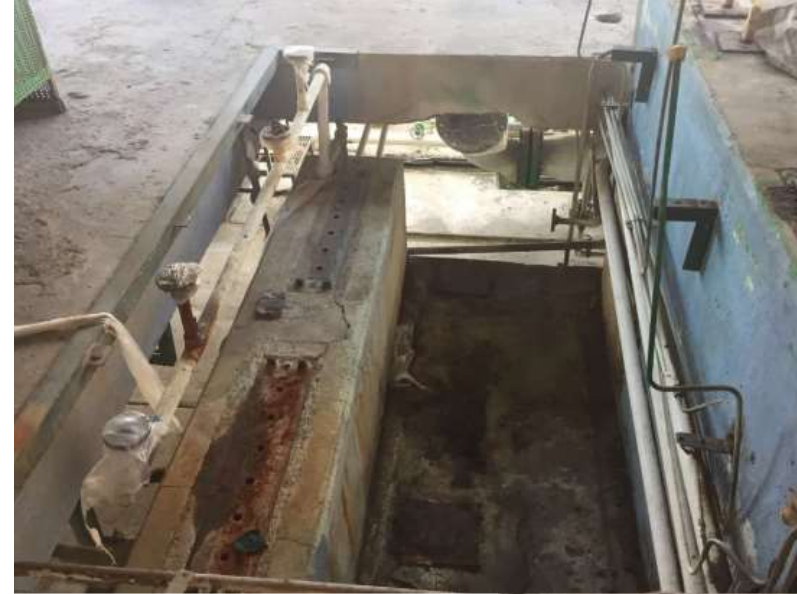
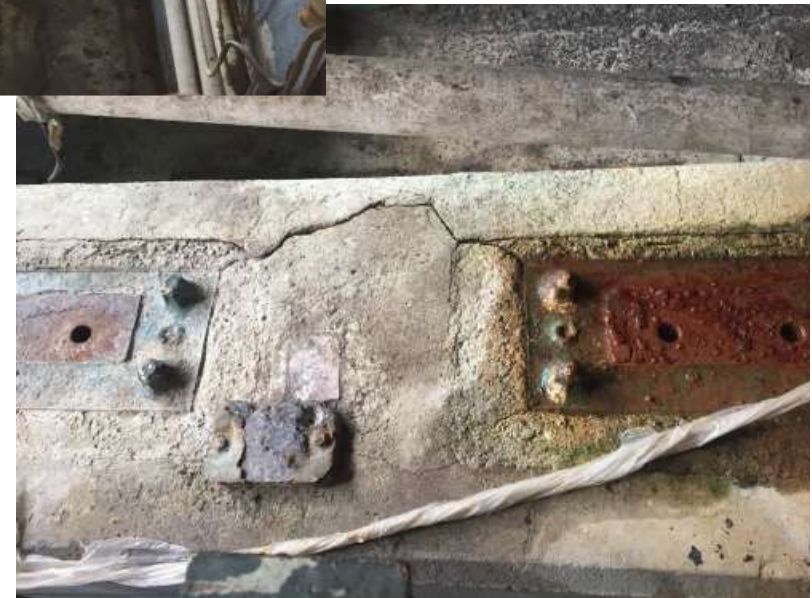
## 1st Step - Evaluate overall condition of foundation system

- Alignment verified by tensioning anchor bolts to recommended preload.
- Based on this assessment, determined that only the piston loaded areas would require foundation remediation.

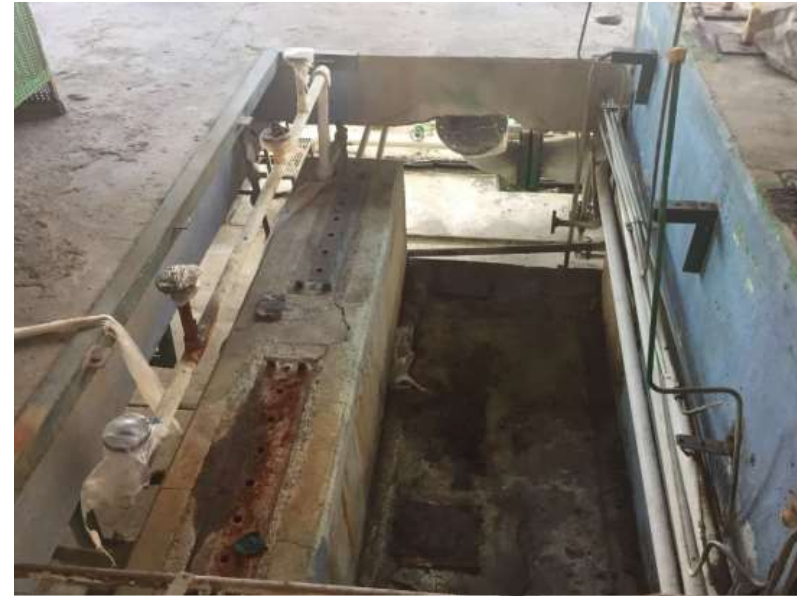
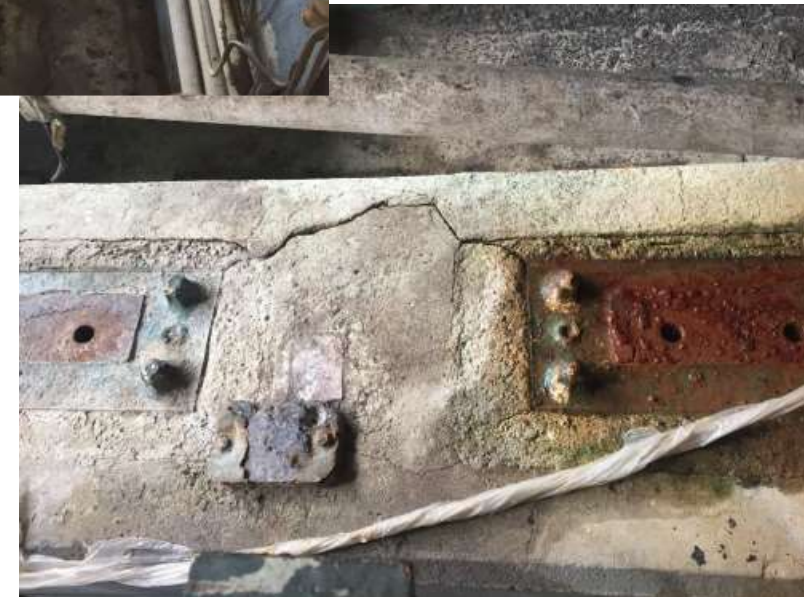
## 1st Step - Evaluate overall condition of foundation system

A remediation design was created through effective collaboration between project stakeholders.

- Remove and replace existing anchor bolts.
- A best-in-class, precision epoxy grout was selected to connect new anchor bolts and sole plates to existing concrete foundation.

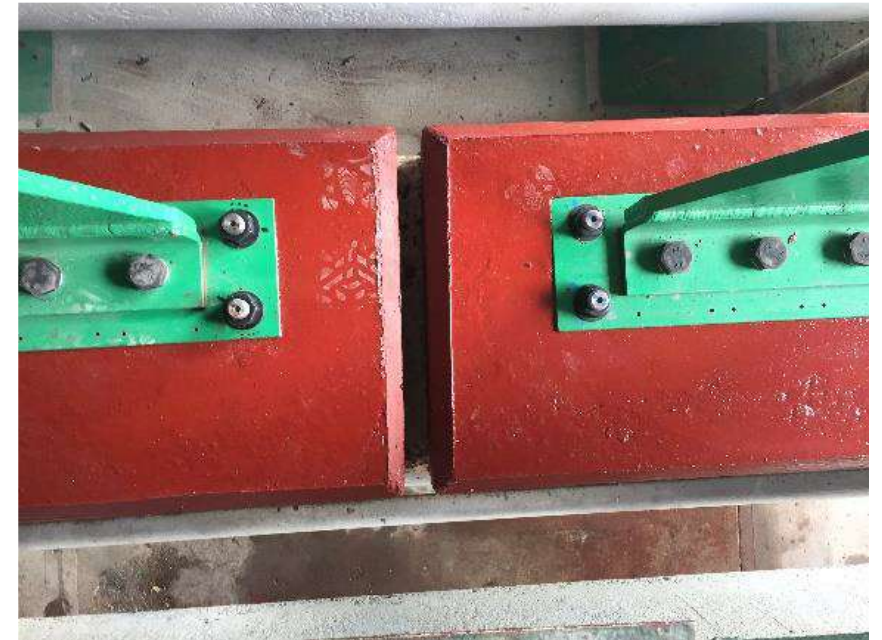
*A follow up visit was conducted approximately 1 year after the initial installation. At that time, the anchor bolts were observed to be maintaining the proper tension without concern and the compressor was reported to have been operating very well. There were no concerns with excessive vibrations or wear to the mechanical components of the compressor. The remediation was considered a success.*
