Devcon® R-Flex® Prolongs Spliced Conveyor Belt Service Life at Copper Mine

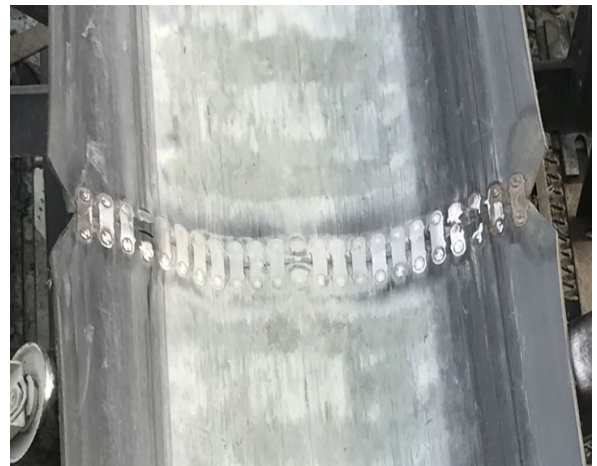
At a copper mine, mechanical splicing is utilized to conjoin two large sections of a conveyor belt used to transport ore raw material to the processing facility. Metal fasteners used in the mechanical splicing faced consistent wear and corrosion due to handling a large influx of abrasive ore as well as exposure to harsh environmental conditions. As a result of corrosive and abrasive wear, the metal splices began to weaken, potentially creating more or new damage to the conveyor belt. The customer was looking for a long-term durable coating that would withstand continuous wear and abrasion.

Corroded and abraded metal splicing

Devcon R-Flex coating was used to repair and protect the damaged clips.

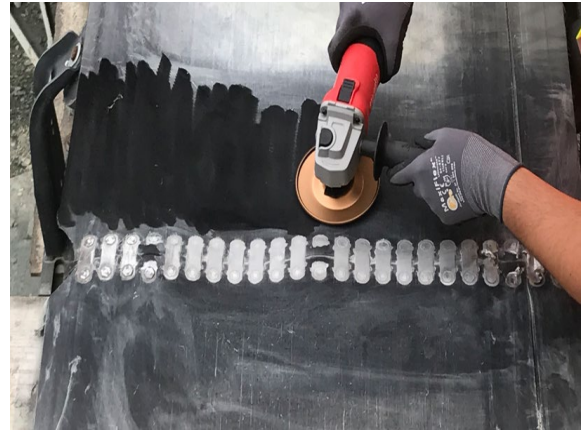
Abrading 8" with disc plate between metal splicing

- Using recommended product instructions for optimal substrate adhesion, the belt was cleaned, and metal clips were primed with solvent.
- An area of 8" on either side of the belt fasteners was abraded to prepare the substrate for Devcon R-Flex application.
- Devcon Metal Clip primer was brushed onto the fasteners and left for ten minutes to dry.
- Devcon R-Flex was then easily mixed and poured over the damaged metal clips at a thickness of $\frac{1}{8}$ ".
- The repair area was then left to cure for a total of 90 minutes before returning the conveyor belt back to service.

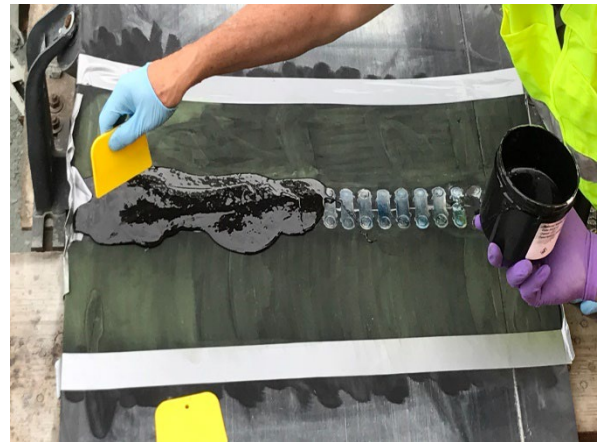
Devcon R-Flex application to metal splicing
