Devcon Flexane Putty Repairs and Protects Chemical Tank from Leak

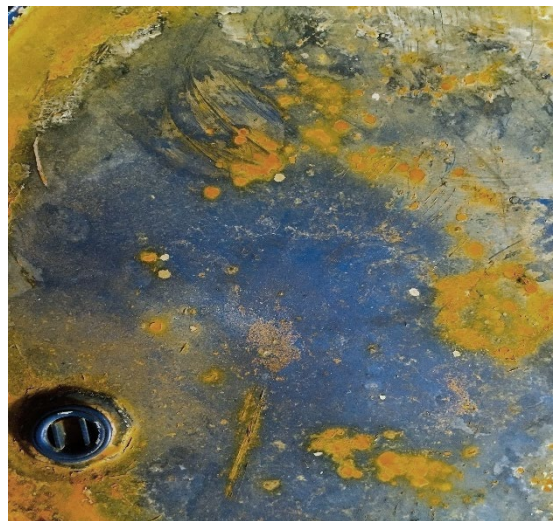
An external tank containing 50m³ (1765 ft³) of sodium hypochlorite (bleach) began to leak in a petrochemical facility putting the health and safety of plant employees at risk. Due to the hazardous nature of the chemical leak, the tank required an immediate repair to limit any spillage of this volatile material. In addition, the external surface of the tank that needed emergency repair was located outdoors and thus exposed to varying climate conditions.

Sodium hypochlorite tank damage

- To prime the surface for repair, the damaged and corroded portions of the tank were removed.
- Devcon Devweld 531 was applied to the surface, fiberglass tape was placed over the Devweld 531 embedding the glass in the Devweld 531. Devcon Devweld 531 was able to provide required adhesion to the nylon material coating the tank.
- Devcon Flexane 80 Putty was then applied to the top of the fiberglass tape. The Flexane 80 Putty was molded by hand with a putty knife to ensure a smooth surface coating.

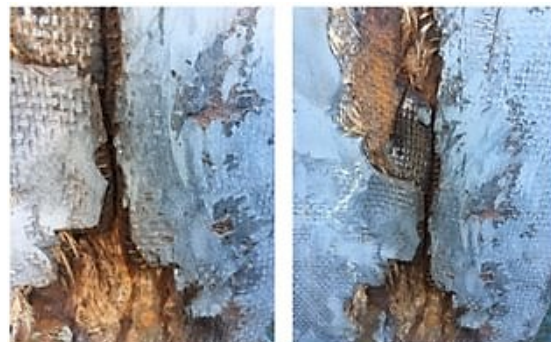
Chemically corroded external tank

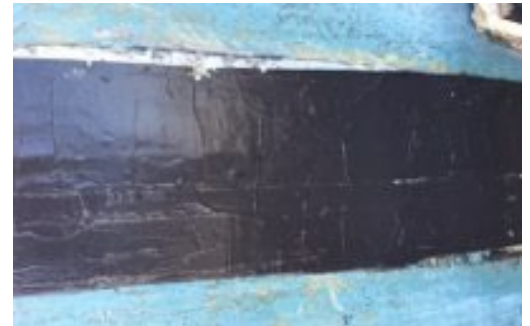
Devcon Flexane Putty applied to external tank

The durable, emergency tank repairs now have the ability to hold hazardous material and withstand environmental hazards until the next planned shutdown or scheduled preventive maintenance.
