Devcon® Putties Repair & Protect Pipe Header from Corrosive Salt Water

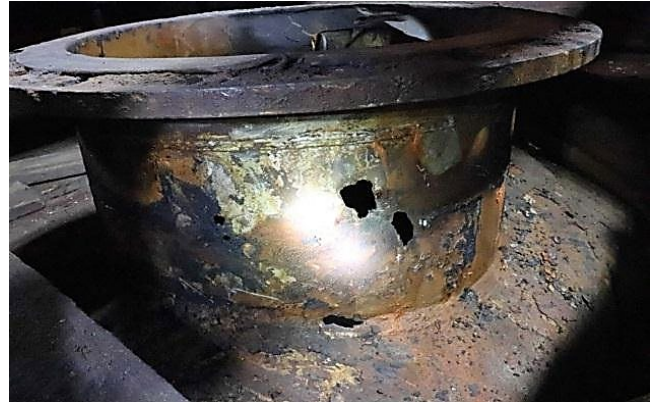
At a steel plant in Saudi Arabia, a damaged seawater outlet header had a large leak on the side of its DN600 nozzle. It was evident the nozzle damage was too severe to be contained with temporary measures. In addition, the rubber lining within the carbon steel pipe was also damaged.

Damaged FPF sea water nozzle (DN600)

- The surface was cleaned and steel filled, fast setting Devcon Plastic Steel 5 Minute Putty (SF) was applied to rebuild the missing metal. Next, a carbon steel plate was bonded to provide additional reinforcement to the repaired area.
- The repaired surface was then coated with Devcon Flexane General Purpose Putty to mimic the rubber lining and match the needed height of the rubber.
- A composite wrap was used for structural reinforcement, bringing the damaged sea water outlet header up to its original strength following the ISO 24817 code.

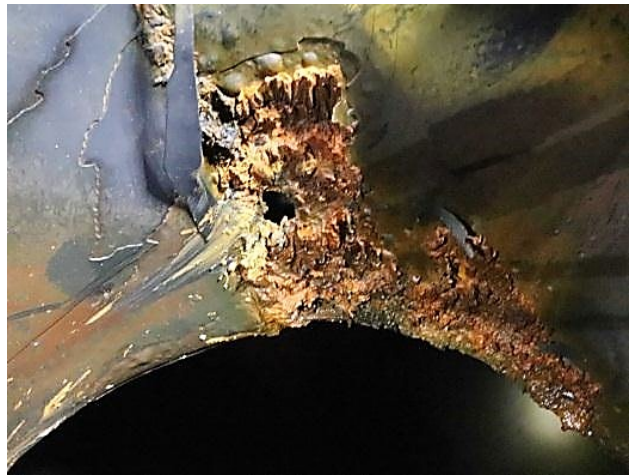
Given the cooling process was highly corrosive and would continue to negatively affect the carbon steel pipe, especially the flange on top of the return header, a durable corrosion resistant coating was required to provide long-term protection and reduce maintenance repair time.

Close-up of corrosion before repair

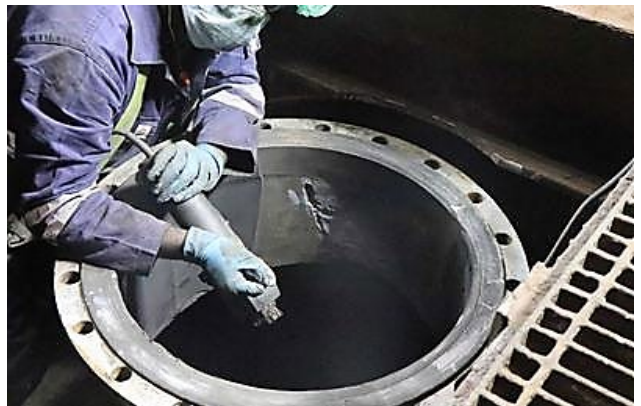
FPF sea water nozzle rubber lining with gouge

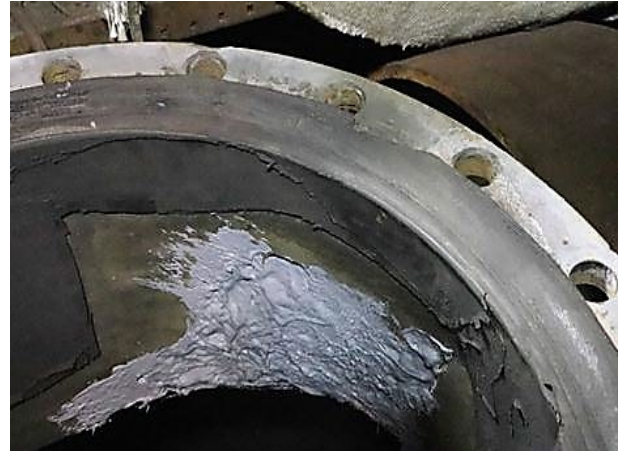
Devcon Plastic Steel 5 Minute Putty (SF) applied to rebuild the missing metal in header interior

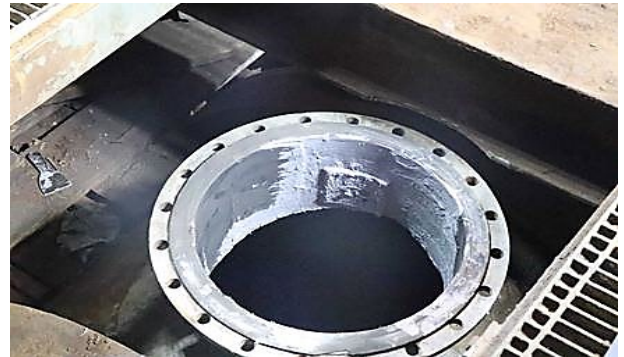
Devcon Plastic Steel 5 Minute Putty (SF) used to bond a reinforcement steel plate over the damaged area

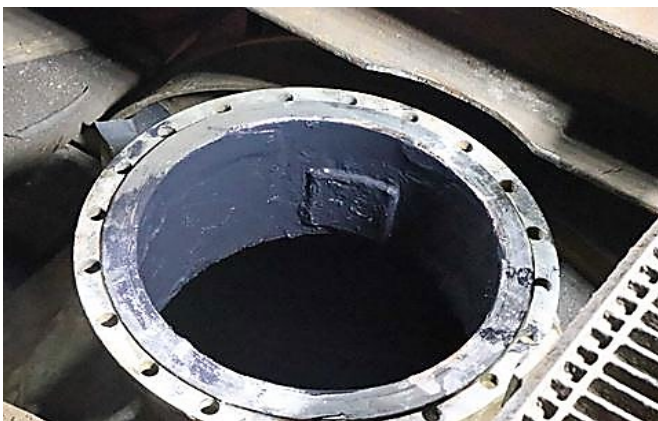
Devcon Flexane General Purpose Putty applied to the repaired surface and on the rubber lining to provide seamless protection

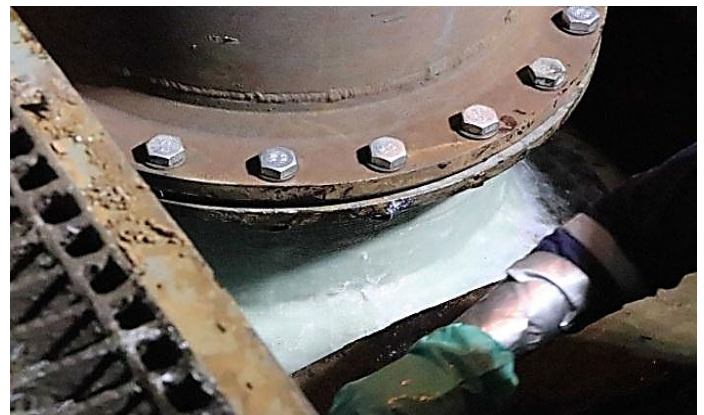
Repaired sea water outlet header back in service
