## Highly Durable Devcon® Brushable Ceramic Coating Withstands Petrochemical Desalting Process

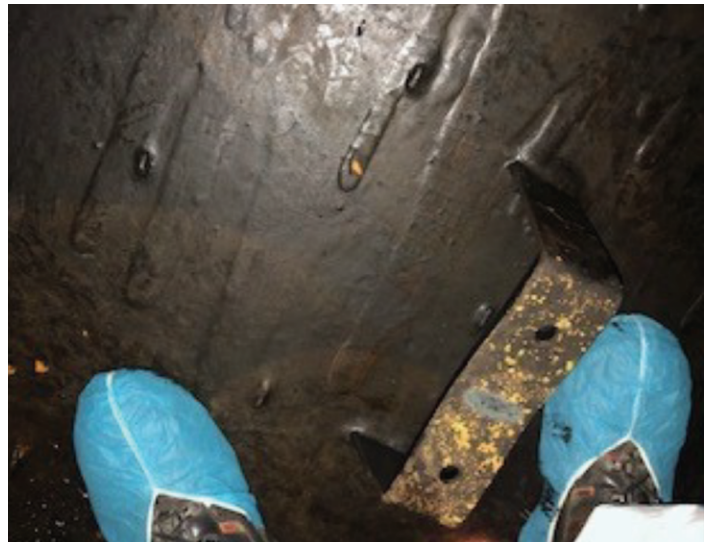
In 2021, at the end of the scheduled 6-year life cycle maintenance, the tank was inspected, and it was found that although the Brushable Ceramic had changed to a black color, the coating remained intact and providing protection to the tank & weld seams.

Internal Coatings of Devcon Brushable Ceramic after 6 years

A full inspection revealed minor damage to the coatings, but these were in difficult to reach areas such as the manhole covers. The failures identified were far less than the customer's target 10% failure rate thereby meeting their expectations. As a result, they reapplied the Devcon Brushable Ceramic Coating and returned the tank back to service.

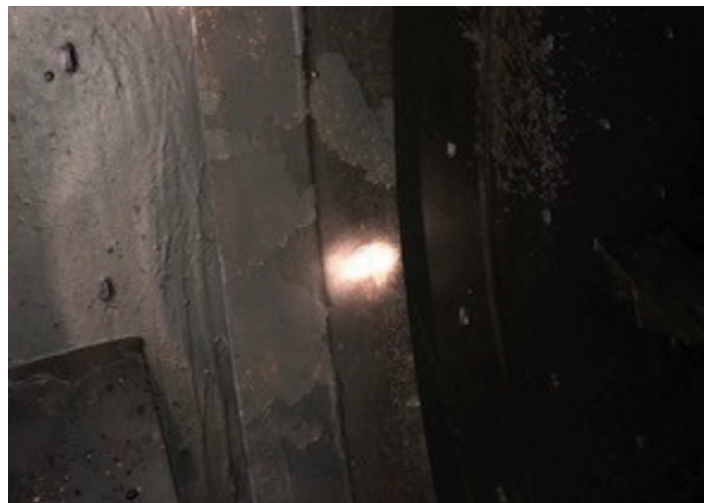
Devcon Brushable Ceramic Coating after 6 years

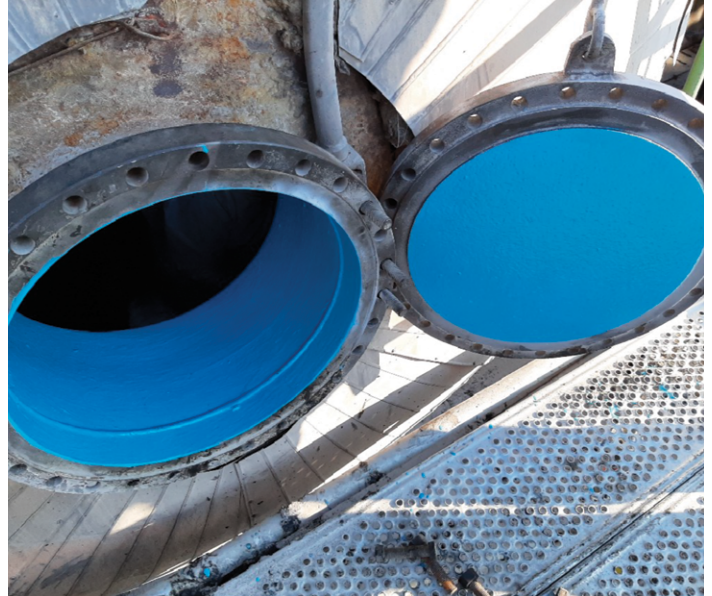
*After being recoated with Devcon Brushable Ceramic Blue*

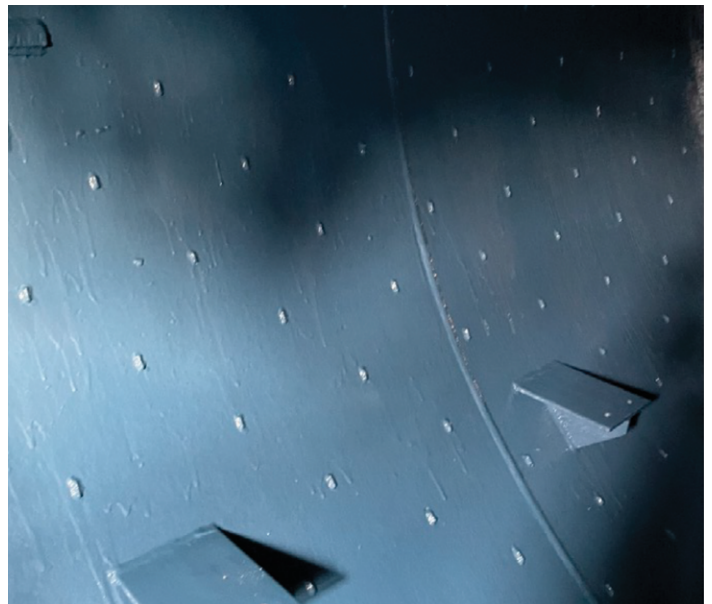
*Recoated with Devcon Brushable Ceramic Blue*
