Devcon® R-Flex® Belt Repair Provides 3X Durability vs Competitive Material

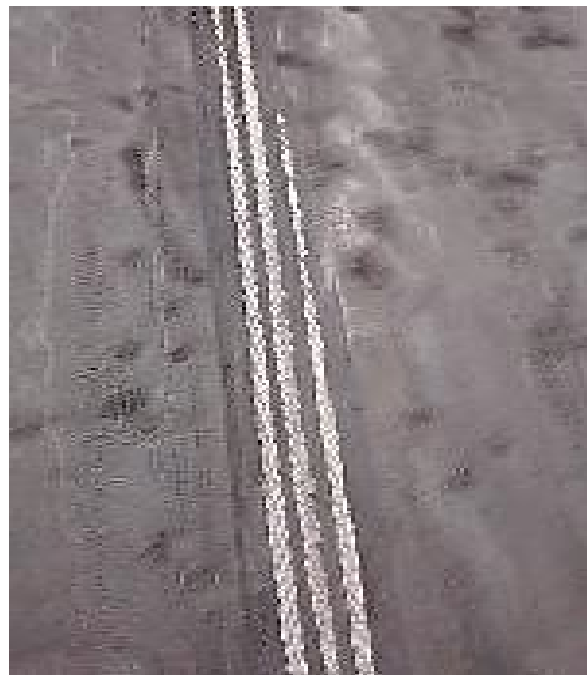
At a copper mine, an SBR conveyor belt is used to transport ore from raw material processing to the refining area of the plant. This conveyor belt covers an extensive distance and plays a major role in the overall functional operation of the plant. However, due to handling large amounts of ore raw material, the conveyor belt faced multiple grooves and tears to the rubber lining. In addition, frequent damage to the conveyor belt impacted plant productivity. The client was looking for a durable, long-lasting belt repair solution to withstand the extreme environment of ore processing and maintain belt uptime.

Grooves in copper mine conveyor belt

The belt was successfully repaired with Devcon R-Flex to provide durable protection against abrasive wear.

- The conveyor belt was cleared of all raw material in preparation for surface priming.
- For optimal adhesion purposes, the area surrounding the damaged belt area was abraded with a disc pad.
- A surface conditioner was applied to the damaged area to rid the surface of contaminants.
- Devcon R-Flex was then mixed and poured onto the belt grooves at a thickness of $\frac{1}{8}$ " and left to cure for 90 minutes, to provide long-term abrasive wear protection.

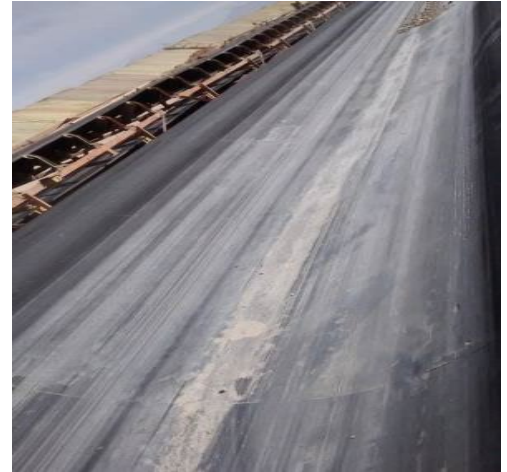
Copper mine conveyor belt

Despite hot and humid installation conditions, **Devcon R-Flex coating** was seamlessly applied to the damaged belt area and the equipment was back in operation in under two hours.
