Devcon® Flexane® Putty and Devweld 531 Provide Corrosion Protection to Petrochemical Holding Tank

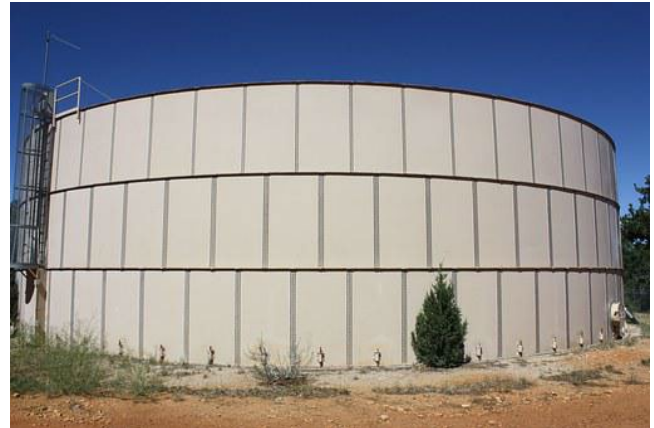
The corrosive nature of sodium hypochlorite caused the lining of the tank to become damaged that could lead to a tank leak if not properly resolved. Immediate repair was needed to limit future spillage. The plant required a fast-acting coating that provided corrosion protection in challenging environments.

Holding tank

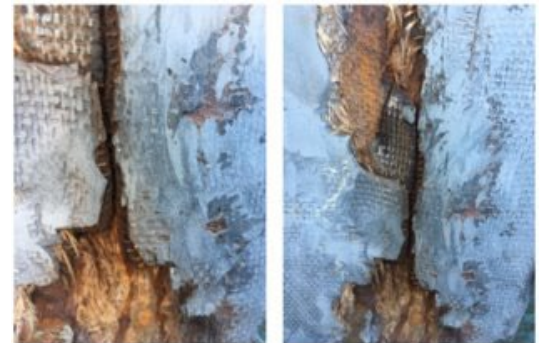
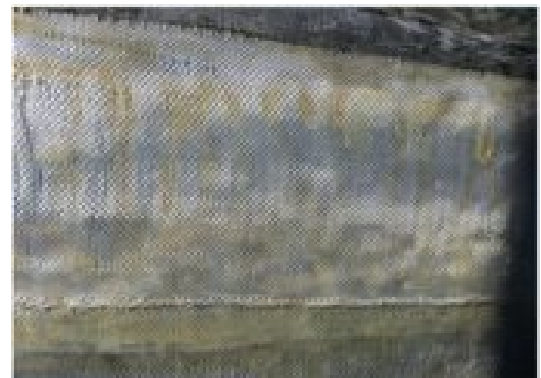
Chemically corroded external tank

- To prime the surface, the repair area was exposed; and damaged and corroded portions of the tank removed.
- Devcon Devweld 531 was applied to the surface and fiberglass tape was placed over the damaged area.
- Devcon Devweld 531 provided excellent adhesion to the nylon material coating the tank.
- Devcon Flexane 80 Putty was applied to the top of the fiberglass tape. The product was molded by hand with a putty knife to ensuring a smooth surface coating.

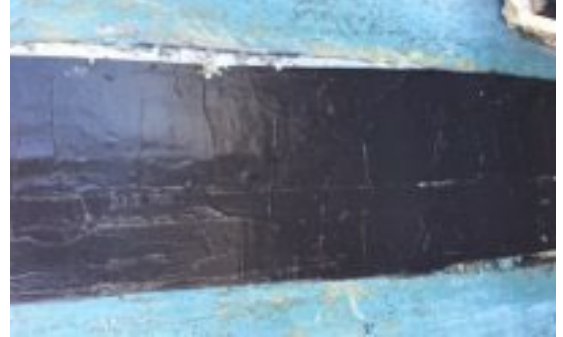
Devcon Flexane Putty applied to external tank

The tank needed a coating that would protect the inner lining from severe corrosion. Devcon Flexane 80 Putty and Devweld 531 provided the shell of the equipment with long-term resistance to chemical attack.
