Rapid Repair of Transport Belt at Shale Limestone Mine with Devcon® R-Flex®

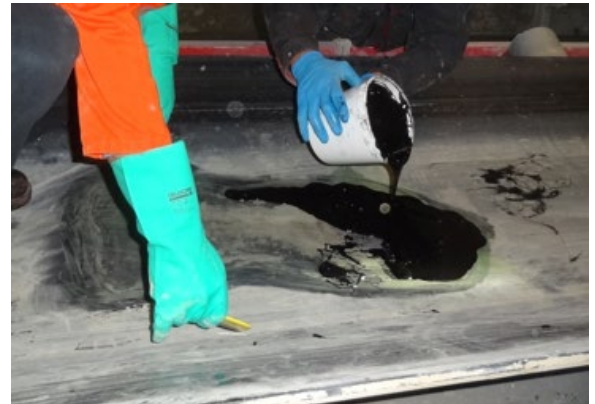
R-Flex being poured onto damaged transport belt area

- In preparation for Devcon R-Flex application, the main transport belt was cleared of all raw material surrounding the damaged area of the equipment.
- For optimal adhesion, the rubber surface of the transport belt was roughened into the rubber using an abrasive disc pad and cleaned with Devcon Cleaner Blend 300.
- Devcon R-Flex resin and curing agent were easily mixed and poured onto the damaged section of the transport belt.
- The industrial strength epoxy was then smoothed to desired thickness and left to cure for a total of 90 minutes.

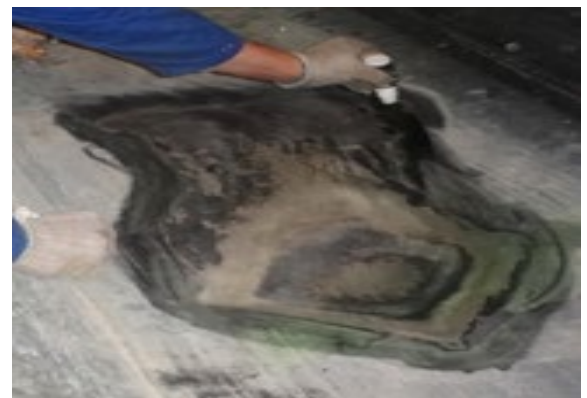
At a shale limestone mine, a main transport belt conveys limestone aggregate to the processing area of the plant. The lining of the transport belt, made of a flexible rubber material, faces infrastructure damage and abrasive wear from long operating hours and consistent transport of the heavy materials. Abrasive wear of the transport belt also resulted in multiple areas of the equipment facing damage. A quick repair of the belt was needed to address these issues and continue raw material transport and processing.

Damaged area of the transport belt

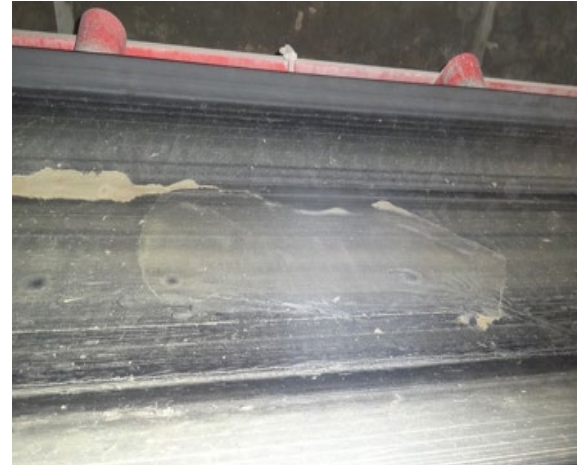
Devcon R-Flex repair system application

Devcon R-Flex was seamlessly installed by mine maintenance personnel in under 2 hours by following the simple application steps.
