Devcon® R-Flex® Repairs Belt in 90 Minutes at Copper Mine

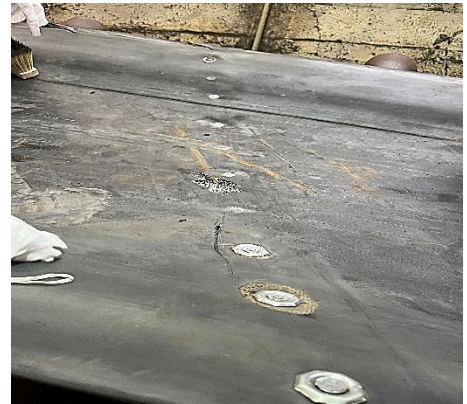
A world leading copper producer experienced damage to their conveyor belt system. Typically, belting was repaired using metal clips. However, these created the additional problem of not only damaging scrapers, but the clip repairs were prone to creating more damage to the belt over time.

Damaged conveyor belt

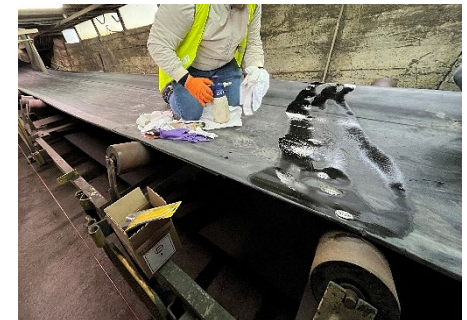
Conveyor belt surface cleaned with acetone

- The surface was cleaned using a soft brush and acetone (around 10cm away from each side of the metal clips), after which the surface was abraded using an abrasive disc, including abrading the metal clips. With a cloth and acetone, the surface was cleaned again to remove residual rubber.

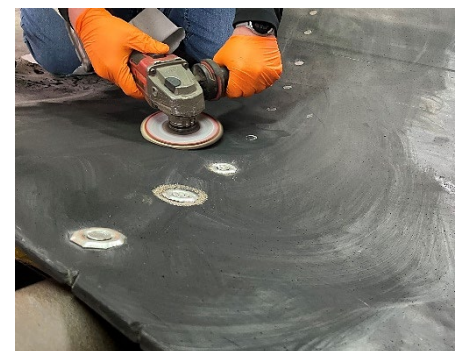
Surface abrasion with abrasive wheel

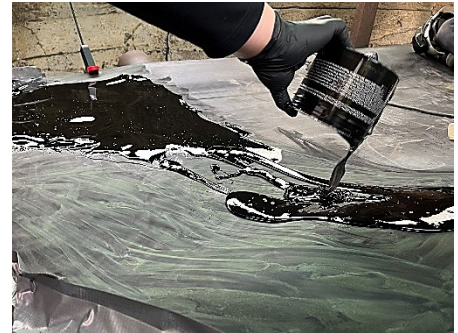
Applying Devcon R-Flex coating

- Mounting protective tape controlled the product flow as the application was on an inclined surface. Then the Devcon R-Flex was poured onto the heavy weight belt and over the metal clips. Using a plastic applicator, the Devcon R-Flex was spread over the belt surface and feathered edges were achieved.

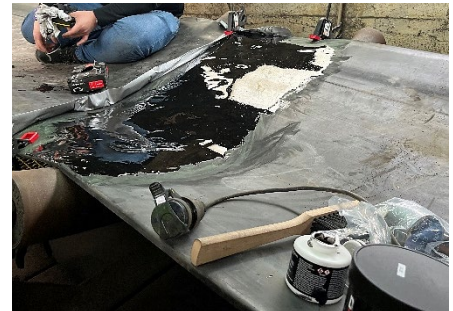
Devcon R-Flex curing

- The Devcon R-Flex chemistry was robust enough to perform the repair in a cool environment. As the ambient temperature was at 59°F / 15°C the Devcon R-Flex could be accelerated with the aid of a portable heater to accelerate the curing process.
