Devcon® Wear Guard™ Fine Load Helps Prolong Service Life of Copper Transfer Pipe

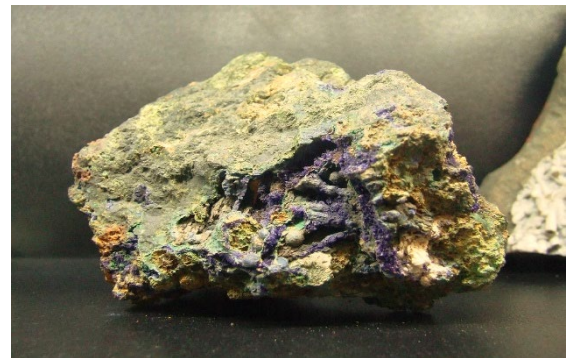
Copper ore feedstock

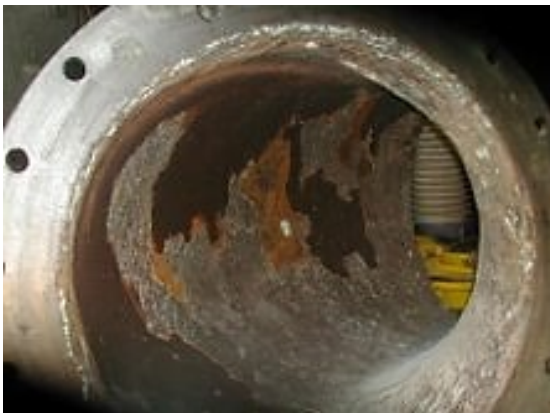
At a copper mine, transfer pipes carry slurry of copper ore to the froth flotation machine. The transfer pipes began to suffer wear due to the highly abrasive nature of the copper ore slurry. The inner lining of the transfer pipes was severely worn, and without an effective repair solution, the equipment required frequent and costly pipe replacement in order to maintain routine operations. By replacing the corroded transfer pipes on a regular basis, this copper plant faced higher maintenance cost and equipment downtime.

Corroded transfer pipe

Devcon Wear Guard Fine Load was selected to repair the transfer pipes due to its proven performance in these challenging environments.

- To ensure adhesion to the substrate, the transfer pipe was cleaned and abraded until white metal was exposed.
- Devcon Wear Guard Fine Load was applied to the internal surface of the pipe elbow by personnel in only a few easy-to-follow application steps.
- The coated surface was then smoothed with Acetone to ensure a smooth surface within the pipe.

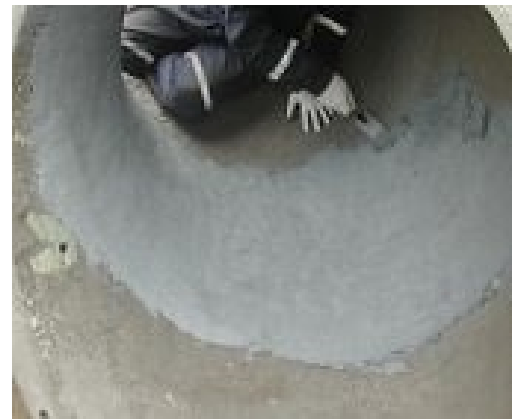
Application of Devcon Wear Guard Fine Load to transfer pipe

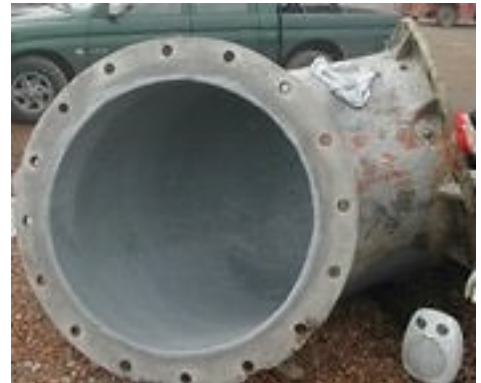
With the capabilities of Devcon Wear Guard Fine Load, the main challenges facing this copper plant were effectively resolved. By applying Devcon industrial strength epoxy coating to the inside of the transfer pipes, corrosion and wear was eliminated despite exposure to the highly abrasive slurry.

Fully repaired transfer pipe
