Devcon® Wear Guard™ High Temp Withstands Extreme Temperatures of Steel Plant Coke Processing

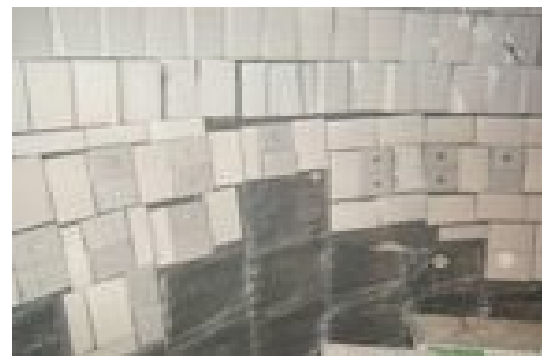
As part of the dry coke quenching system, the pressure cyclone at a steel plant uses high temperature air to dry coke for optimal burning. Despite allowing for a more environmentally friendly alternative to wet coke quenching, this system did not come without its challenges. The process cyclone, made of ceramic tile, began to wear and fail at the seams sooner than expected, due to high temperature exposure and high impact handling of raw material. The equipment had to be taken offline and the client contemplated full replacement of the ceramic tiles as well as industrial strength epoxy coating solutions.

Damaged ceramic tile

- The cyclone was emptied of remaining coke and cooled to safely apply the industrial strength epoxy.
- The tiles were then abraded to ensure optimal adhesion to the epoxy coating and cleaned in high areas of wear, predominantly at the seams of the tiles.
- Devcon Wear Guard High Temp ceramic bead reinforced epoxy system was easily applied to the seams of the cyclone in a few application steps.
- In order to speed up the final cure of the coating, the cyclone was turned on to a higher temperature.

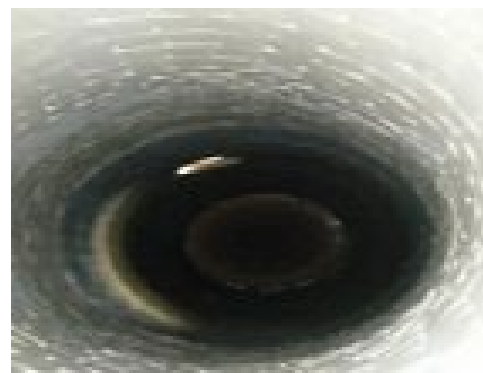
Vertical view of cyclone separator
