# Chockfast

## Escoweld 7505E / 7530 Grouting Compound Provides Precision Alignment for Silo Loading Cells

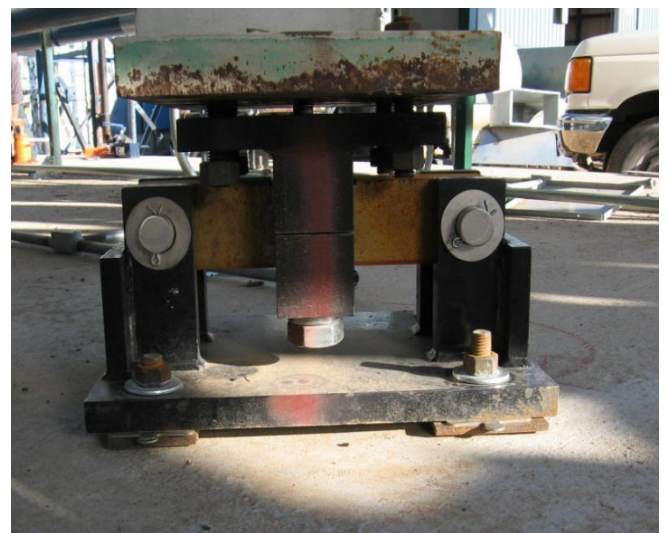
At an agricultural facility, four independent load cells located underneath the silos are used to gather information on weight and volume of grain for transportation and processing. Significant process impact caused excessive vibration on the pads and the loading cells. This caused detrimental interference to the load cells resulting in inaccurate weight measurements.

*Silo loading cell*

- The load cells were aligned and then chocked to the original foundation.
- Forms were established around the load cells, to make space for grouting installation, supporting the alignment of the equipment.
- Escoweld 7505E / 7530 was then mixed using a mechanical mortar mixer until all components were thoroughly combined.
- Escoweld 7505E / 7530 was poured into the forms beneath the loading cells and left to cure for 24 hours.

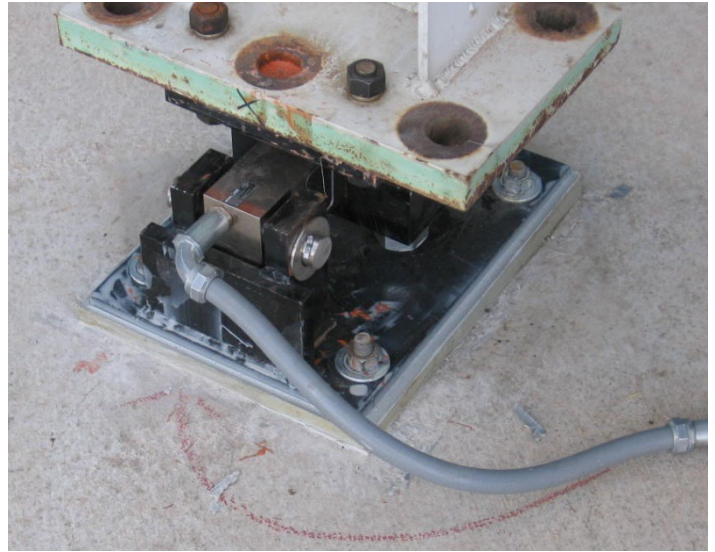
*Loading cell after Escoweld installation*

This agricultural plant needed a grouting solution that would maintain the critical calibrations and specifications of the loading cell. By utilizing Escoweld 7505E / 7530, the loading cells could be secured and aligned with the silos to dampen vibrations, helping to optimize the cells' performance.

If gone unchecked, the vibrations would have led to inaccuracies with the loading cells and additional calibration requirements. However, Escoweld 7505E / 7530 was able to prevent the detrimental vibration entirely from impacting the sensitive requirements of the equipment.
