## **Innovative Remediation Techniques to Compressor Foundation Systems**

**12<sup>th</sup> Conference of the EFRC**  
**March 9<sup>th</sup> – 11th, 2021, Warsaw**

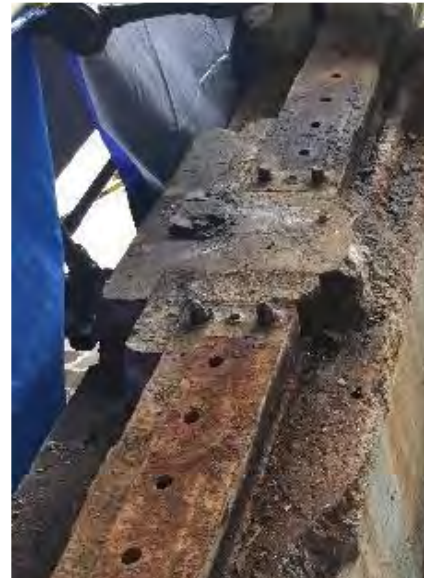
The compressor was originally installed in 1978. When installed originally, the foundation was mounted on a cementitious grout. Over time, the vibrations resulting from the operation of the compressor steadily increased. This resulted in extensive mechanical damage to the compressor, as well as damage to the foundation system. Initial efforts were made to ensure the proper tensioning of the anchor bolts, but the bolts kept relaxing over time. The vibrations eventually increased to the point that the equipment could no longer be operated due safety concerns.

*Figure 2: Removal of Existing Cementious Grout*

Removal of the existing sole plates and the damaged cementious grout was performed. Please see Figure 2, Figure 3, & Figure 4 for detail on the initial condition and removal of the previously installed transfer medium.

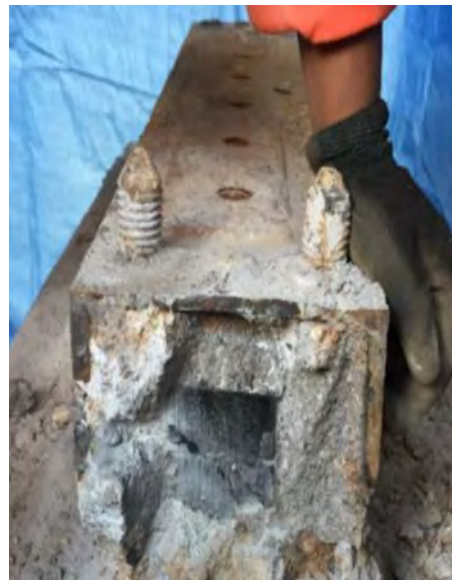
*Figure 3: Degradation of Existing Cementious Grout under Support Rails*

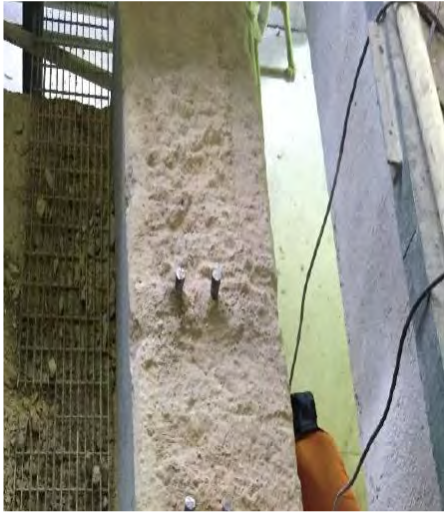
*Figure 4: Surface of Concrete after removal of Cementitious Grout and Support Rails*

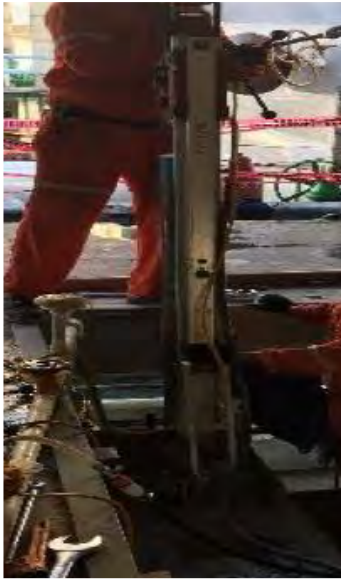
*Figure 5: Core Drilling Damaged Anchor Bolts*

This step also included removal of the anchor bolts using a core drill. Core drilling was performed using a 6" OD core drill bit and were drilled down to a depth of 1000 mm, to accommodate the new bolts with a length of 950 mm. Please see Figure 5 & Figure 6 for details on the removal process of the anchor bolts and the foundation after core drilling was completed.

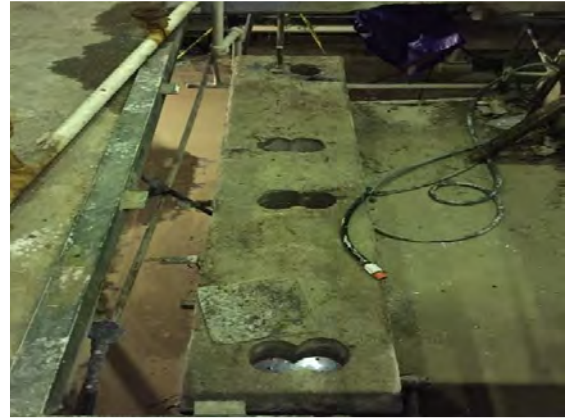
*Figure 6: Foundation After Damaged Anchor Bolts Removed*

A total of 4 support rails and 16 damaged bolts were removed under the compressor. The core drilling of the anchor bolts also allowed access for further inspection of the cracks within the concrete foundation, as well as the overall integrity of the concrete block.

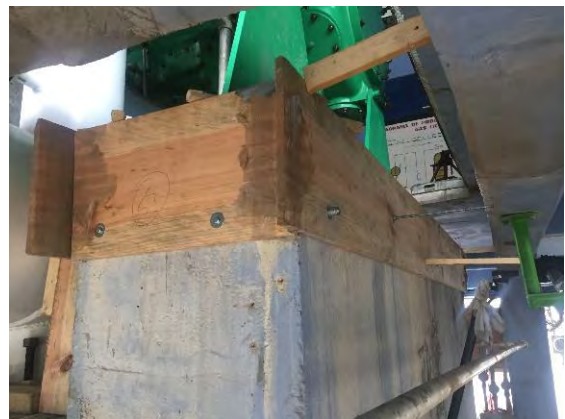
*Figure 7: Formwork for Mounting Support Rails on Epoxy Grout*

After delivery of the new anchor bolts was completed, the final portion of the foundation overhaul could be completed. The new anchor bolts were Class 8.8 per ISO 898-1. After ensuring that the anchor bolts were cleaned, the compressor was aligned, and the anchor bolts were hung into the newly drilled anchor bolt pockets. Formwork was constructed to allow filling of the mounting area. The mounting area under the compressor support rails were filled with a superior epoxy grout, as recommended and installed by the regional foundation expert team. Please see Figure 7 & Figure 8 for preparation and pouring of the epoxy grout under the compressor.

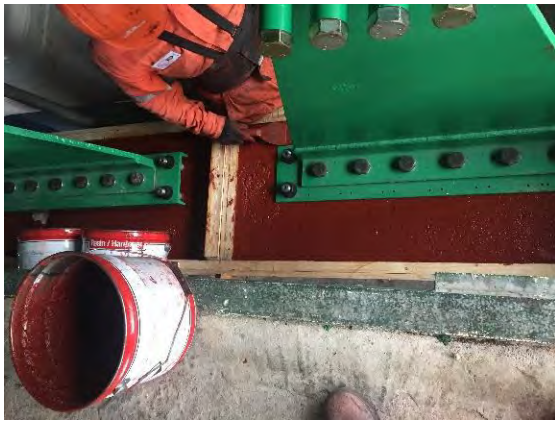
*Figure 8: Superior Epoxy Grout Installed Under Compressor Support Rails*

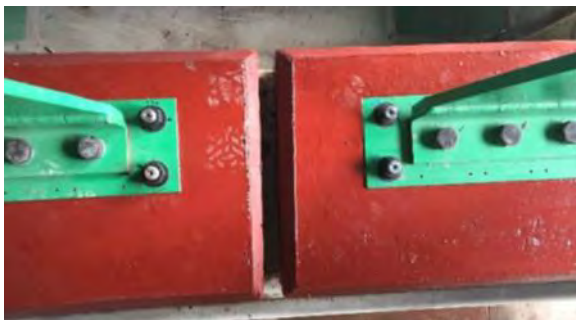
*Figure 9: Final View of Compressor Support Rails on Superior Epoxy Grout*

After sufficient time had elapsed, as advised per the recommendations of the epoxy grout manufacturer, the formwork was removed, the removable alignment devices were backed out, and the anchor bolts were properly tensioned per the recommendations of the OEM. Please see Figure 9 for a view of the final mounting of the compressor.

A follow up visit was conducted approximately 1 year after the initial installation. At that time, the anchor bolts were observed to be maintaining the proper tension without concern and the compressor was reported to have been operating very well. There were no concerns with excessive vibrations or wear to the mechanical components of the compressor.

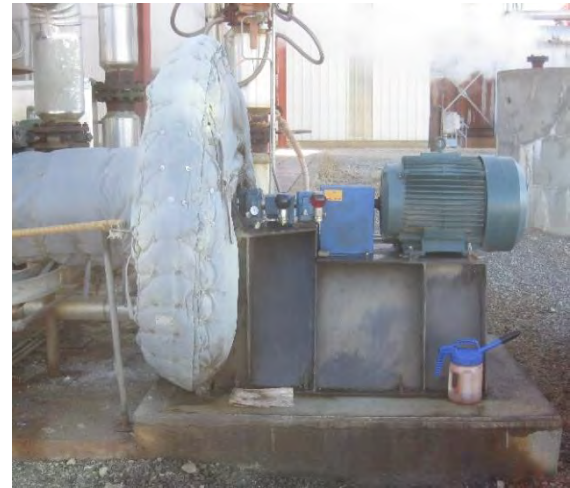
The equipment was originally installed approximately three decades prior to the decision to perform the remediation. Epoxy grout was used in the initial installation and maintained its integrity. The epoxy grout encapsulated the entire top of concrete foundation block, which extended beyond the footprint of the steel baseplate approximately 300 mm (Please see Figure 10). Due to the exposure of the foundation system to the harsh environmental elements, including extreme temperature changes, edge lifting occurred within the concrete below the bond line with the epoxy grout (Please see Figure 11).

*Figure 10: Original Equipment Installation*

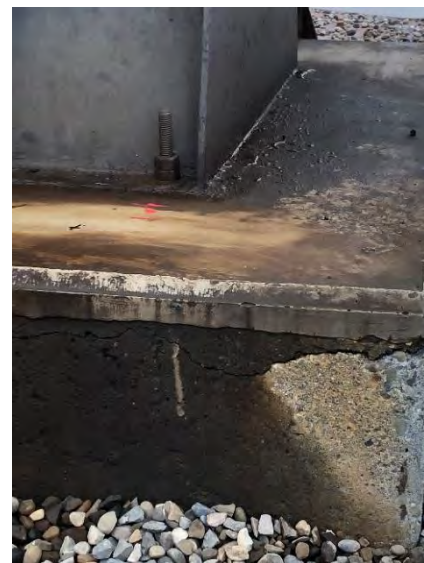
*Figure 11: Edge Lifting on Foundation*

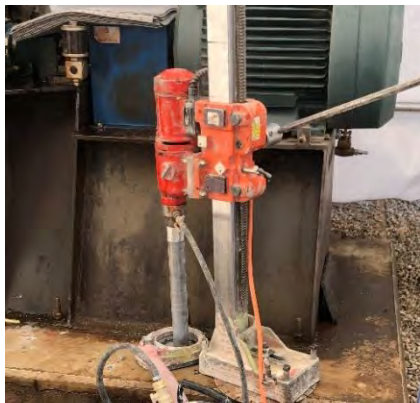
Figure 12: Core Drilling New Anchor Bolt Pockets

The first step was to core drill new anchor bolt pockets through the epoxy grout and into the concrete foundation. The new pockets were approximately 300 mm into the existing concrete foundation. Please see Figure 12 showing the core drilling operation.

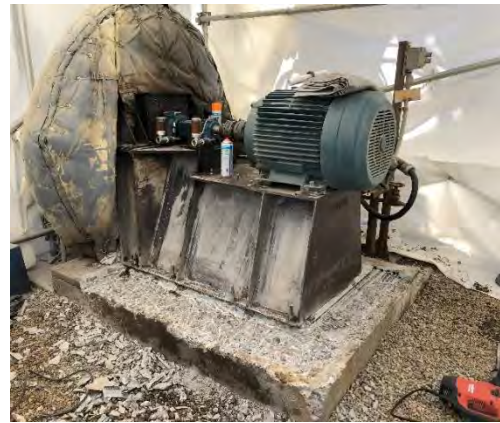
Figure 13: In-Process of Removal of Existing Epoxy Grout and Underlying Concrete

After adding the anchor bolt pockets, hand-held pneumatic chipping guns were used to remove as much of the existing epoxy grout as possible. This was performed to the extent possible by the reach of tooling and kept in place most of the original epoxy grout under the center of the equipment. This also allowed the equipment alignment to be maintained without requiring temporary supports. Existing epoxy grout and underlying concrete were removed until clean and sound concrete was reached and prepared per best practices for installation of a superior epoxy grout. Additionally, the edges and corners of the foundation were chamfered to help minimize the potential for edge lifting to occur in the future. Please see Figure 13

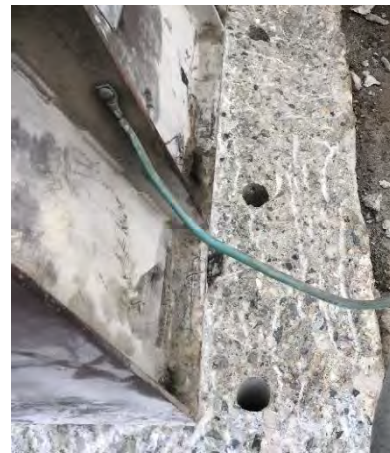
Figure 14: New Anchor Bolt Pockets in Properly Prepared Concrete Surface

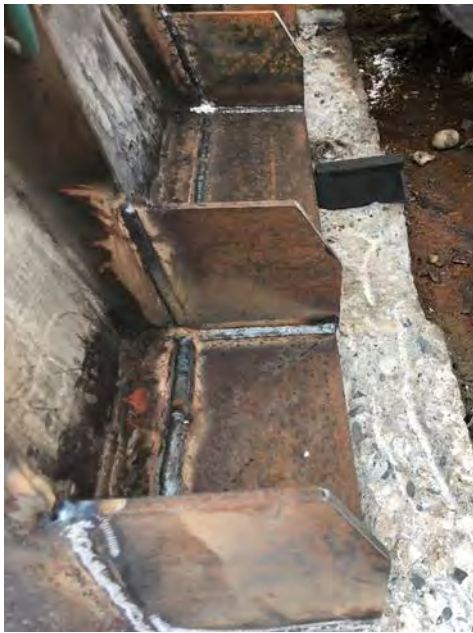
Figure 15: Baseplate Extension Welded to Existing Baseplate

After the surfaces were properly prepared, the formerly used anchor bolts were cut flush with the existing baseplate. In this position, they could not be tensioned and would reduce confusion for future maintenance activities. The newly manufactured baseplate extension was welded to the existing baseplate, as shown in Figure 15.

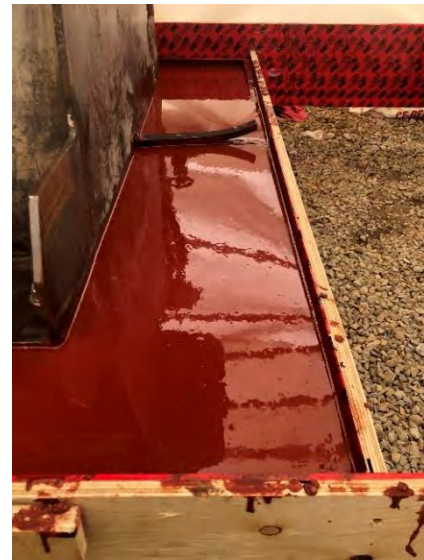
Figure 17: Superior Epoxy Grout Installed in New Anchor Bolt Pockets and Under Baseplate and Baseplate Extension

A superior quality epoxy grout was poured in the anchor bolt pockets and under the baseplate. The entire original epoxy grout cap was encapsulated within the new, superior epoxy grout cap. Control joints were used to segment the pour and allow for expansion and contraction of the epoxy grout due to thermal changes.

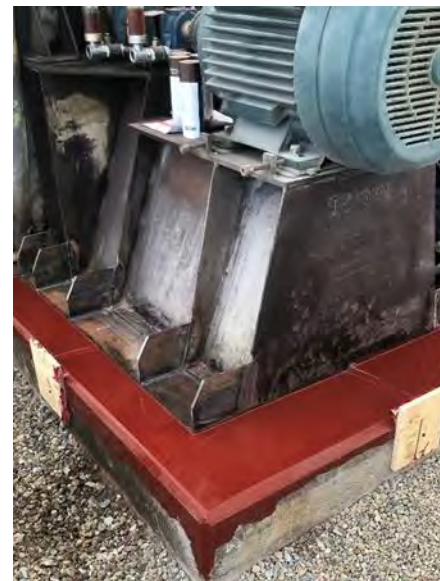
Figure 18: Final View of the Equipment Remediation

After sufficient time had elapsed, as advised per the epoxy grout manufacturer, the formwork was removed, and the anchor bolts were properly tensioned.

After the remediation was performed, the observed vibrations during equipment operation are minimal and greatly reduced from the original situation. The anchor bolt tension has been maintained. The entire remediation only resulted in three days of downtime for this critical piece of equipment and resulted in a significant improvement in operational efficiency.
