Maintenance Costs Reduced on Coal Ash Pump with Devcon Epoxy Coatings

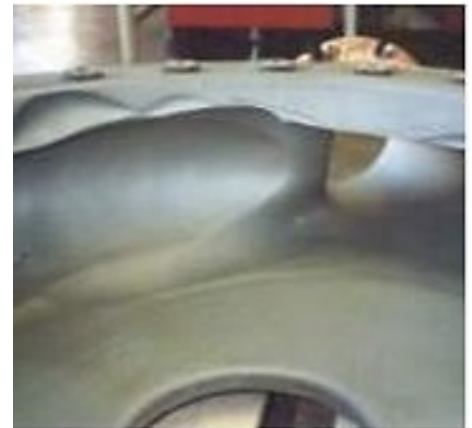
Sandblasted coal ash transfer pump

- The repair area was sandblasted to white metal and the area cleaned with Devcon Cleaner Blend 300, to remove heavy grease and oil deposits on the metal.
- Devcon Ceramic Repair Compound was applied to rebuild wear ring seats, fill holes, and cavitation deeper than 1/8".
- Devcon Wear Guard Fine Load was applied to a thickness of 1/2" to 1 1/2", depending on the depth of wear. Acetone was then used to achieve a smooth finish.
- Devcon Brushable Ceramic Red & Devcon Brushable Ceramic Blue were individually applied to a total thickness of 30 mils.

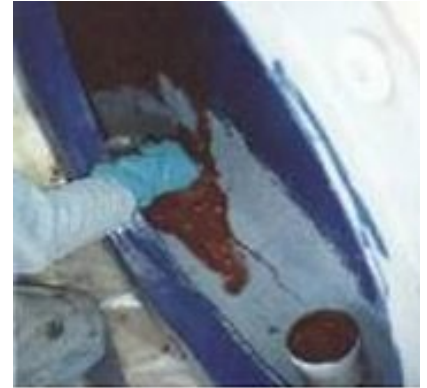
Brushable Ceramic Red applied to transfer pump

- By applying Devcon Wear Guard Fine Load to areas of high wear, this epoxy coating will extend the pump housing life.
- By implementing both Devcon Brushable Ceramic Red and Devcon Brushable Ceramic Blue, the pump housing will be equipped with long-lasting abrasion and chemical protective coatings.

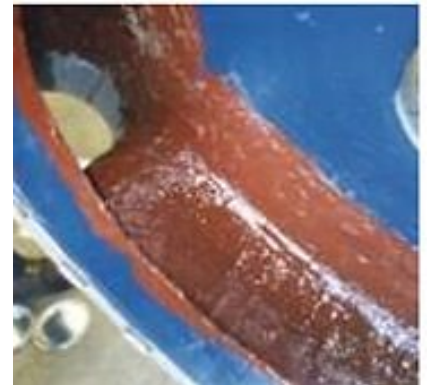
Brushable Ceramic Red finish on transfer pump

By utilizing both Devcon Brushable Ceramic Blue and Red layers, worn-out areas of the pump housing are easily visible as the first color appears in the worn areas.
