53RD TURBOMACHINERY & 40TH PUMP SYMPOSIA
AUGUST 19 - 22, 2024 | HOUSTON, TX | GEORGE R. BROWN CONVENTION CENTER

Existing Compressor Skid Vibration: Anchoring & Grouting Upgrade

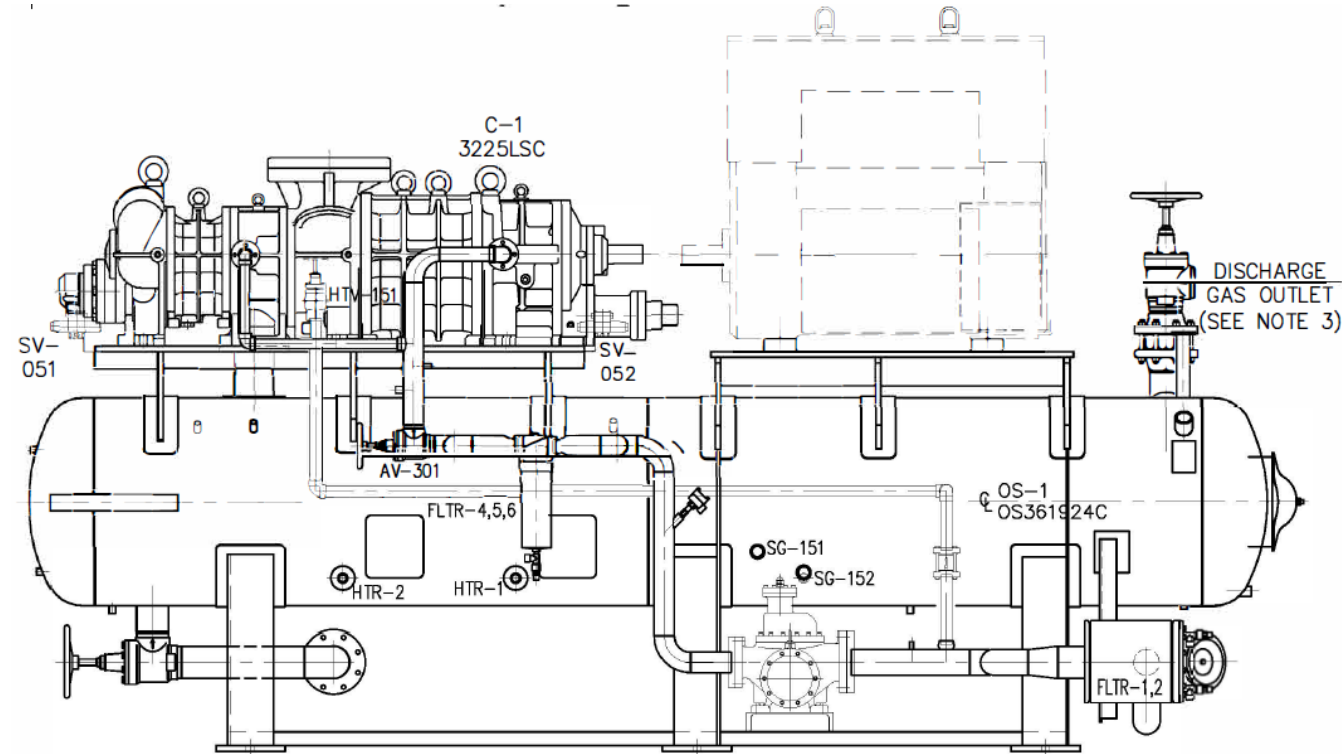
- 1500HP electric motor-driven
- Two-stage compressor
- Oil-flooded rotary screw design
- CO₂ Service
- Commissioned in 2008
- Arrived and initially installed as a full package including compressor, motor, and coalescer vessel
- Initial identification of excessive vibrations at least as early as 2022
- Vibrations trending higher than the rest of the fleet of similarly designed packages

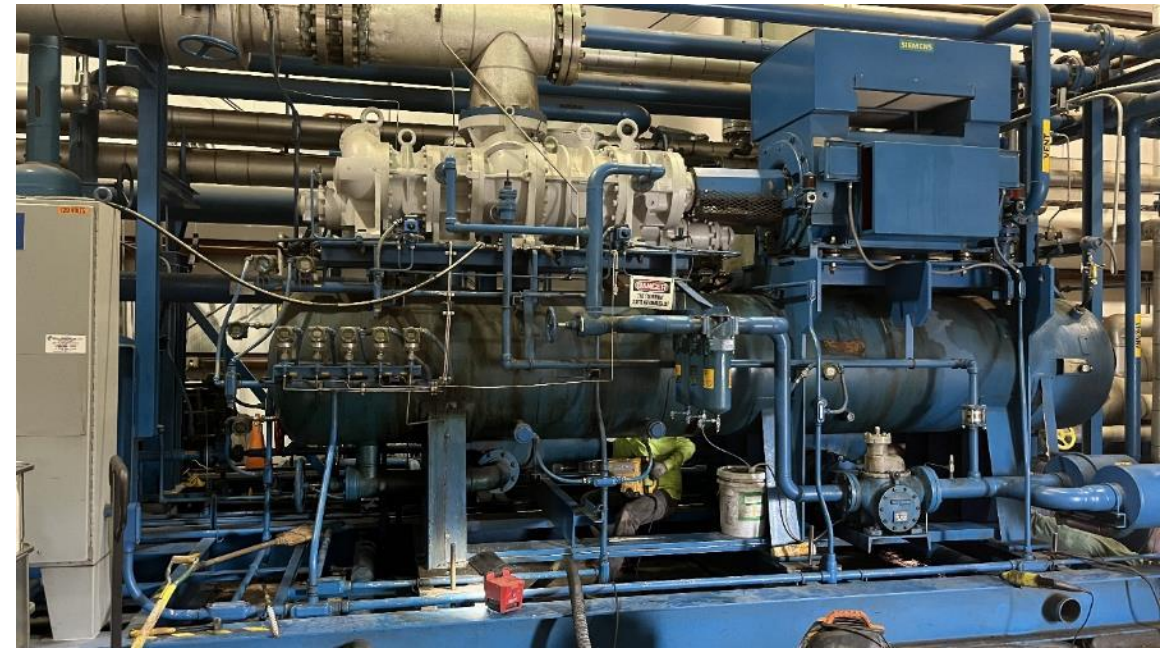
- First replaced the Compressor with spare
 - Previous compressor last rebuild was 2015
 - Vibration readings increased slightly from before
 - Gave evidence vibrations unrelated to mechanical damage within compressor, such as to rotor
- Adjusted process conditions to change pressure ratios to optimum design
 - Vibration readings unchanged

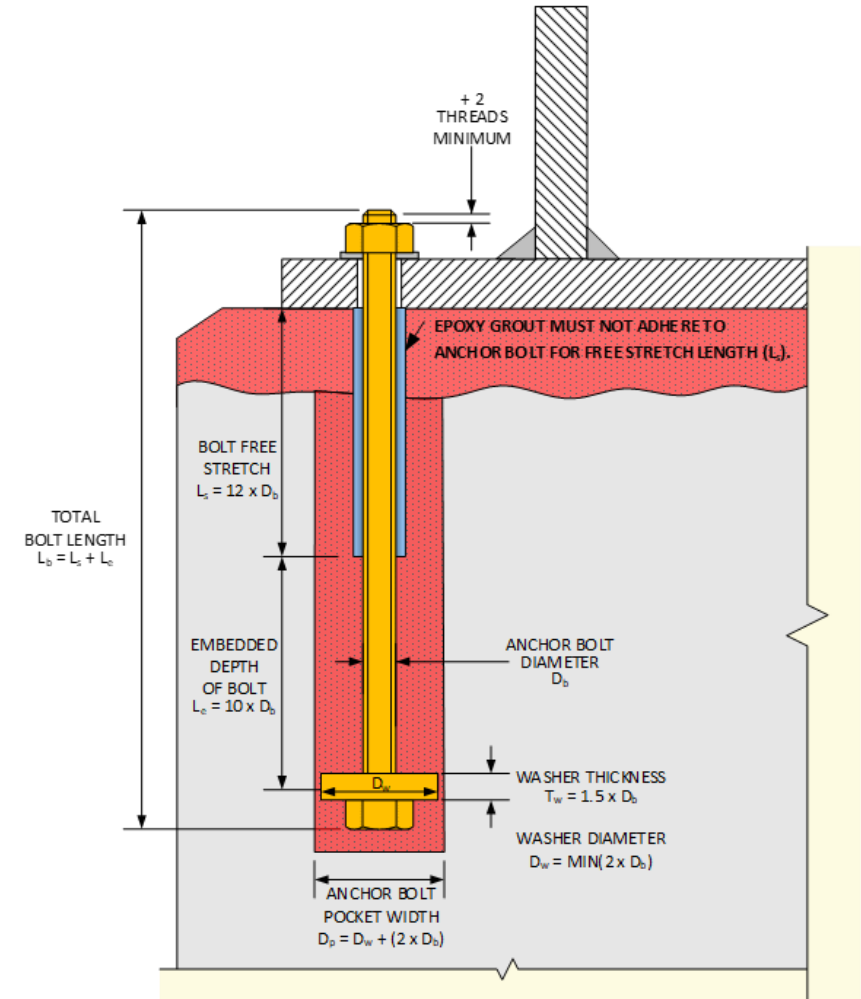
- Anchor Bolt Best Practices
 - Min. 12 bolt diameters of isolation for free stretch
 - Min. 10 bolt diameters of embedment in the foundation
- Limited Concrete 10-in (254-mm) Mat Thickness
- Congested area with compressor remaining in place
 - Filled entire cavity of skid over just around support beams

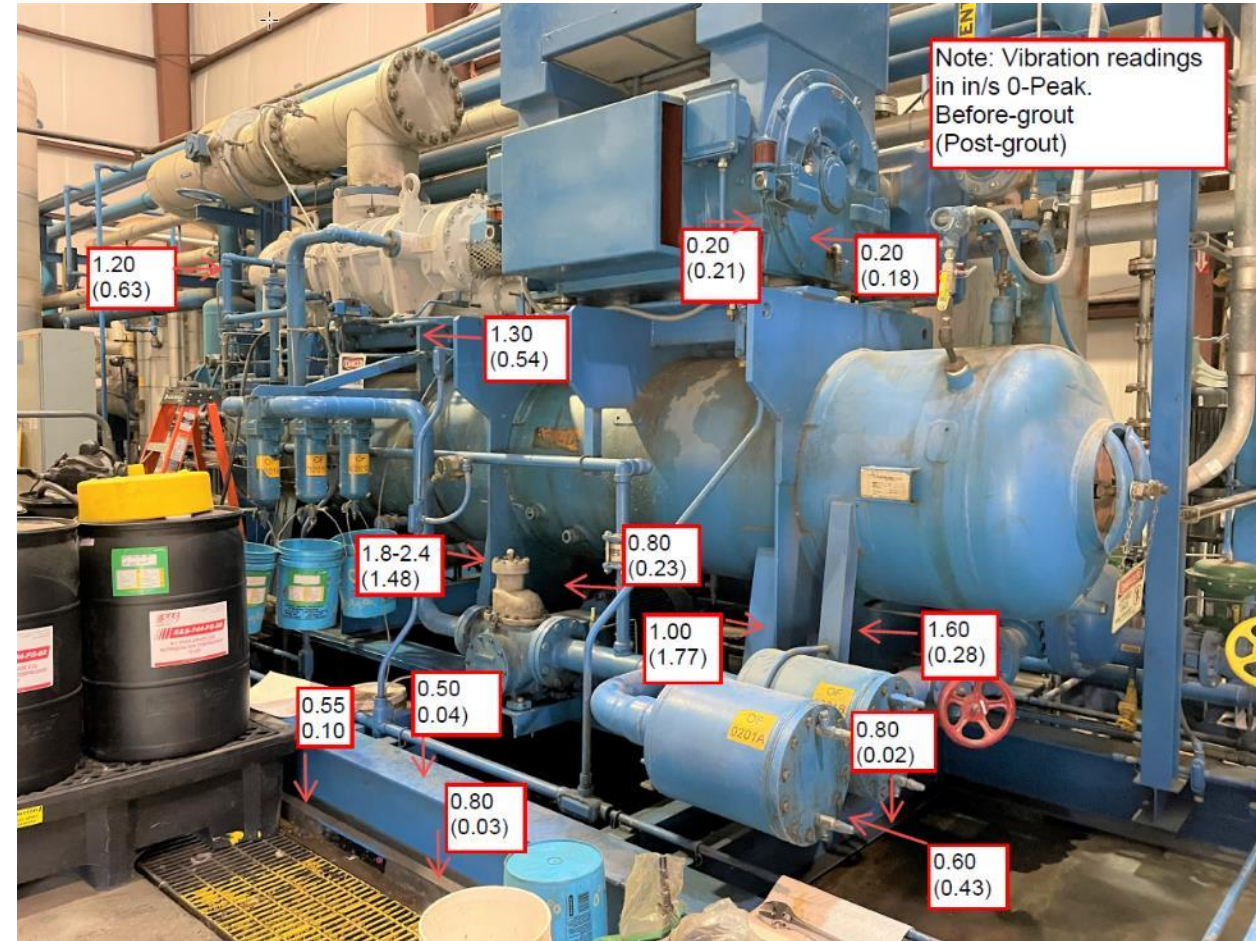
- Frame vibrations were re-evaluated post-grouting, indicating a substantial reduction.
- Considered a success due to:
 - Install execution
 - Vibration reduction
 - Conformance to current installation standards
