Propeller Cavitation & Corrosion Eliminated with Devcon[®] Coating

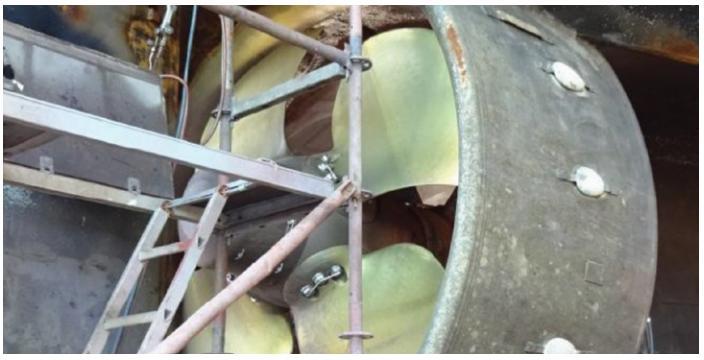
Original propeller casing

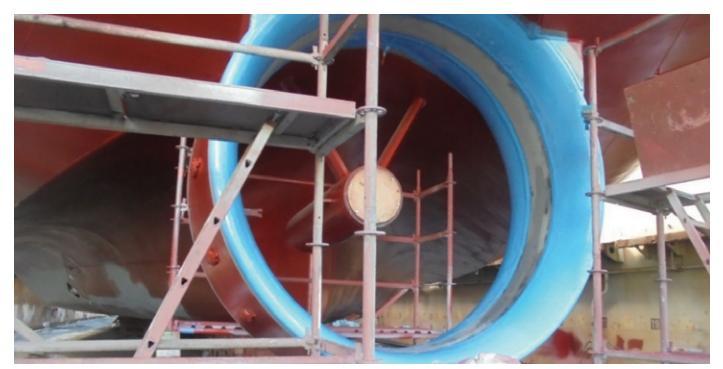
First repair in 2016 with Devcon Brushable Ceramic Blue & Devcon® Titanium Putty

In May 2016, the Propeller casing was sandblasted to remove all corrosion, oxidation and to expose the white metal underneath. Machinable Devcon[®] Titanium Putty Coating was used to repair the cavitation and restore missing pieces of metal to the original dimensions. Corrosion protection was achieved by applying two layers of Devcon[®] Brushable Ceramic Blue Coating by hand. The propeller and ship were then returned to service.

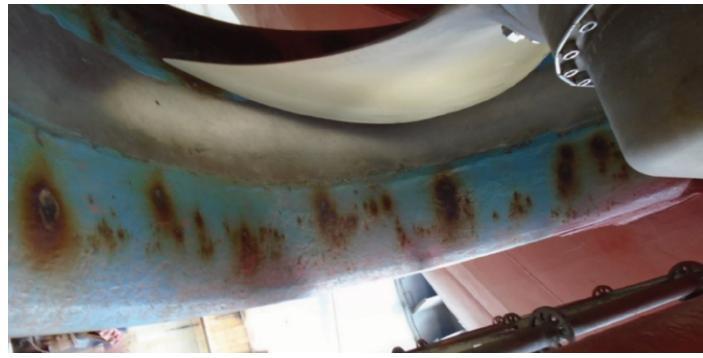
In June 2021, the ship was drydocked as part of the regular maintenance routine. Inspection of the propeller casing showed minimum damage occurred during the 5-year period. The casing exhibited minimal amounts of cavitation and oxidation on the metal. Given this outstanding protection, the Devcon products were used on this second maintenance cycle to repair the propeller casing and return it to service.

Retrieved from service in 2021

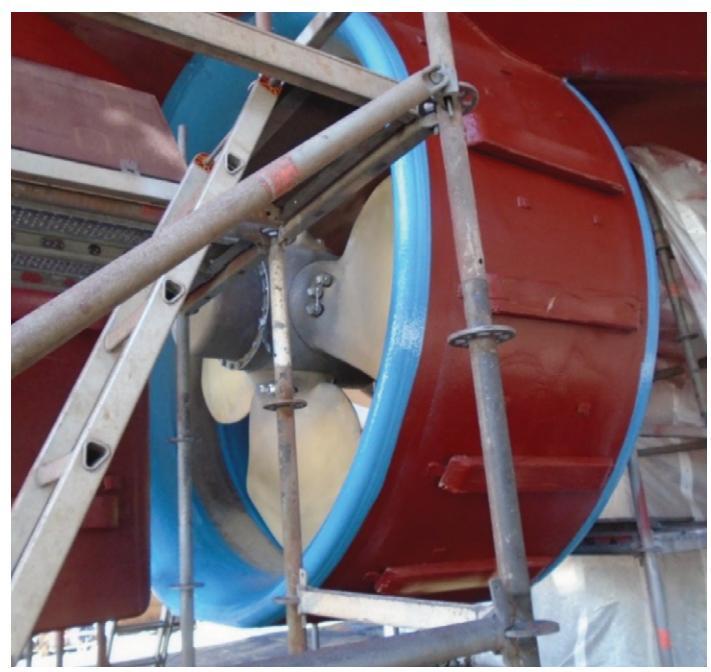
Repaired again in 2021

The metal was sandblasted again, the minimal metal cavitation repaired, and this time, the Ceramic Coating was applied with the new Pneumatic Devcon® EZ-Spray Ceramic Coating System vs manual application. As a result, the propeller was repaired twice as fast and returned to service.

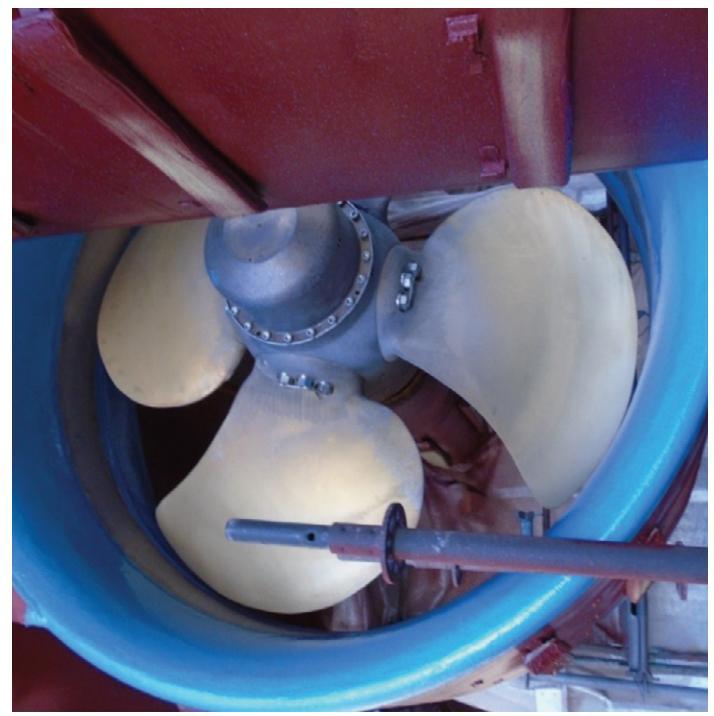
Repaired again in 2021
