Abrasion and Corrosion Damage Reversed at Coal Plant with Devcon® Ceramic Coatings

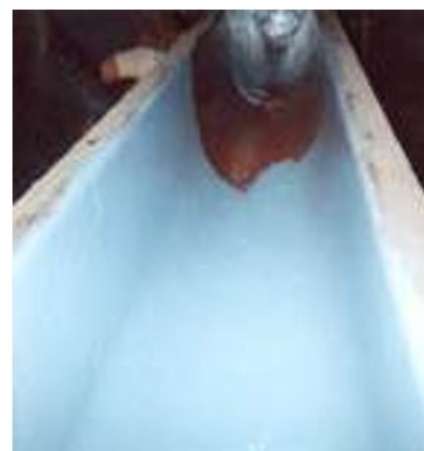
Trough after application of Devcon Brushable Ceramic Blue

- For optimal application, the trough was blasted to a white metal status and wiped with solvent.
- Devcon Ceramic Repair Compound was applied to the worn gouges and holes in the trough, repairing areas of cavitation.
- After a 4-hour cure, two coats of Devcon Brushable Ceramic Coating in red and blue were applied with a thickness of 15 mm for a total coating of 30 mm.
- In order to achieve ideal protection from wear and abrasion, the conveyor screw was also coated with Devcon Ceramic Repair Compound, and Devcon Brushable Ceramic Red / Blue coatings at a total thickness of 30 mm.
- The versatility of Devcon industrial strength epoxies allowed for differing components of the screw conveyor trough to be repaired with only a few easy-to-use products.

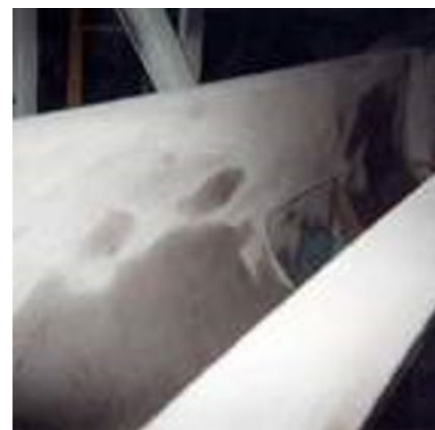
Trough after sand blasting and solvent application

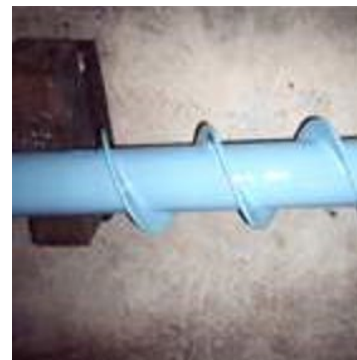
*Screw brushed with
Devcon Brushable Ceramic*

With 12,000 tons of coal processed each day, this plant needed a solution easier and less expensive than metal plates to withstand heavy and abrasive material. Devcon coatings provided the long-lasting protection from corrosion, abrasion, and impact resistance. The client was also able to identify areas of wear for future maintenance activities by coating the trough and screw with layers of Devcon Brushable Ceramic Red and Devcon Brushable Ceramic Blue.

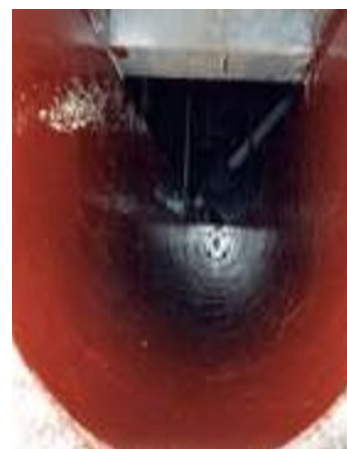
*Devcon Brushable Ceramic
Red applied to screw
conveyor trough*
