Devcon® Combowear FC Protects Conveying Pipe Elbow Against Extreme Environment

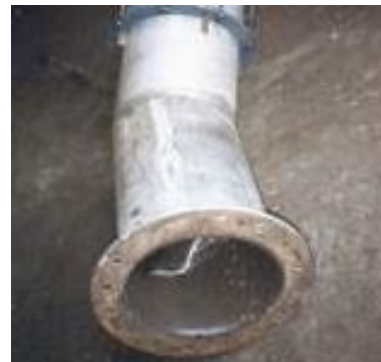
The pneumatic conveying pipe elbows experienced extreme abrasive wear from wet slurries running through the equipment and wearing the elbow joint. As a result, the elbows were replaced every 2 months, leading to costly and time-consuming repairs.

Pneumatic conveying pipe

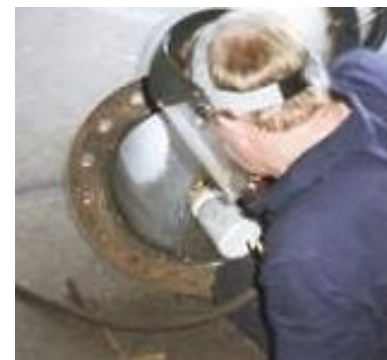
Devcon Combowear FC application to Pneumatic conveying pipe elbow

- Each pneumatic conveying pipe elbow was sandblasted to white metal, ensuring the surface was free of corrosive particles to allow for optimal adhesion for the Combowear Fast Cure application.
- The surface of each pipe was cleaned with Devcon Cleaner Blend 300 to rid the surface of any oil or grease deposits.
- Devcon Combowear Fast Cure was applied to a thickness of ½" to the bottom and vertical surface of the pipe elbows, ensuring maximum protection from abrasive wear.
- Acetone was used to achieve a smooth finish to each pipe elbow.

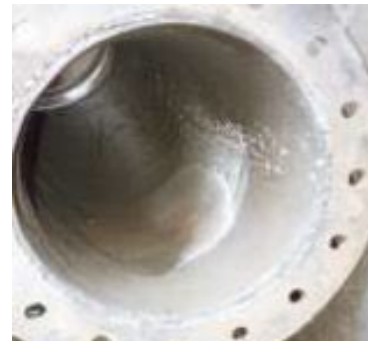
Before Combowear FC

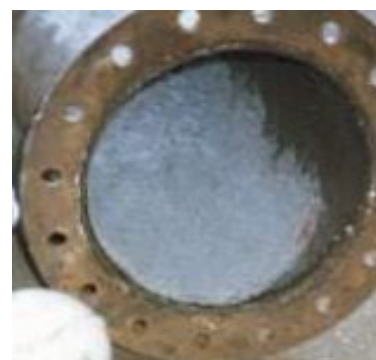
After Combowear FC

Devcon Combowear Fast Cure was applied to areas of high wear, extending the life cycle of the conveying pipe and protecting the equipment against abrasion. Due to the non-sag properties, Devcon Combowear Fast Cure was easily applied to vertical areas of the pipe facing abrasive wear.
