## Devcon® DFense Blok® Repairs and Protects Cyclone Pipe Elbow at Aggregate Facility

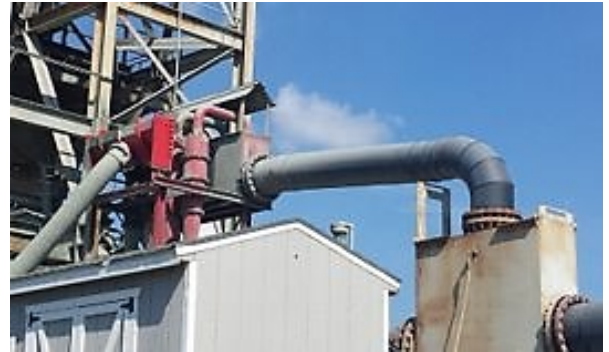
At an aggregate processing plant, the inlet cyclone is used to slow down the flow of raw materials into the equipment and remove large rock. Handling a large volume of materials, the pipe elbow began to face high impact and sliding abrasion. As a result of not only the continual abrasive wear, but the corrosive liquids from the process, the pipes began to develop pinholes and leakage. These pipes needed to be repaired or replaced frequently, leading to high maintenance costs and prolonged shutdown.

*Cyclone pipes*

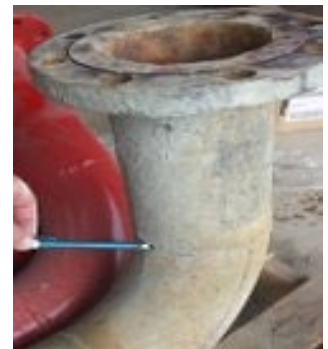
*Worn pin hole leaks*

The customer selected the proven and highly durable Devcon DFense Blok industrial strength epoxy coating to repair & protect the inside of the pipe elbow.

- The pipe was removed from the top of the inlet cyclone, and all debris previously causing abrasive wear was removed.
- The inside of the pipe was grit blasted to white metal in order to rid the surface of rust or any other contamination which could interfere with adhesion to the coating.
- The inside of the pipe elbow experiencing the highest amount of wear was seamlessly coated with Devcon DFense Blok.
- The equipment was then left to cure for a short period of only 5 hours, allowing for the pipe elbow to promptly be put back to use.

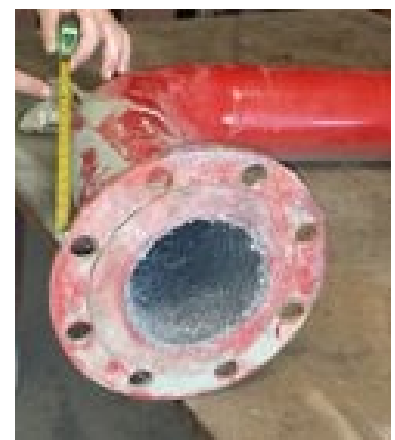
Devcon industrial strength epoxy coating was applied to withstand the severe corrosive and abrasive conditions of the plant processes. Devcon DFense Blok held up to the abrasive environment where frequent high impact and wear from sliding raw materials would normally cause severe damage. As a result, formation of pinholes was minimized and leaks prevented with Devcon DFense Blok high performance coatings. The coated pipes were successfully returned to service.

*Pipe elbow coated with Devcon DFense Blok*
