Devcon® DFense Blok® Protects Gold Mine Drill Cone from Severe Abrasion

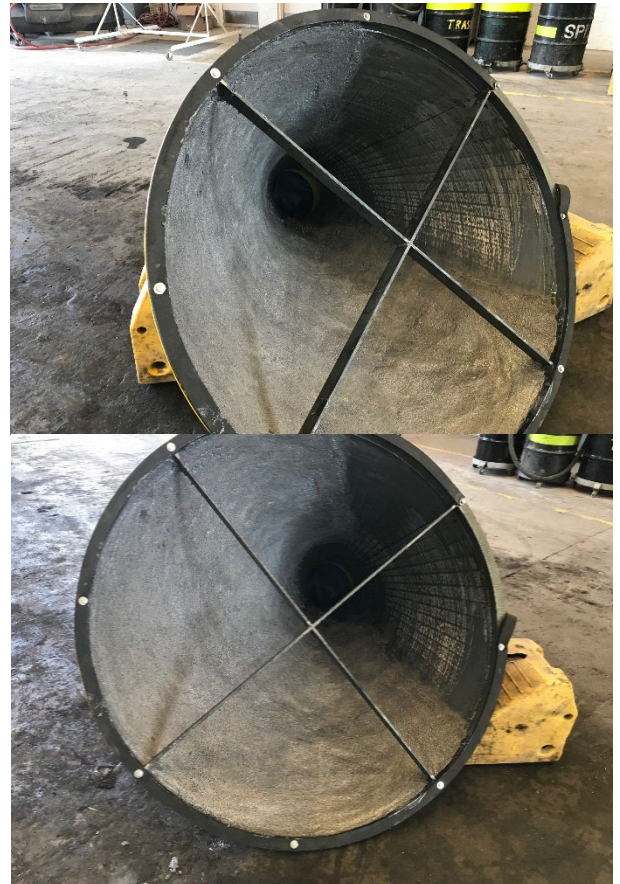
Drill cone coated with Devcon DFense Blok

Devcon DFense Blok coating was used to coat the drill bit and provide protection against wear and abrasion.

Devcon DFense Blok is an extremely effective industrial strength epoxy coating that has withstood even the harshest conditions of the mining industry. By applying Devcon DFense Blok to the inside of the drill cone, the equipment was protected from severe impact and abrasive wear.

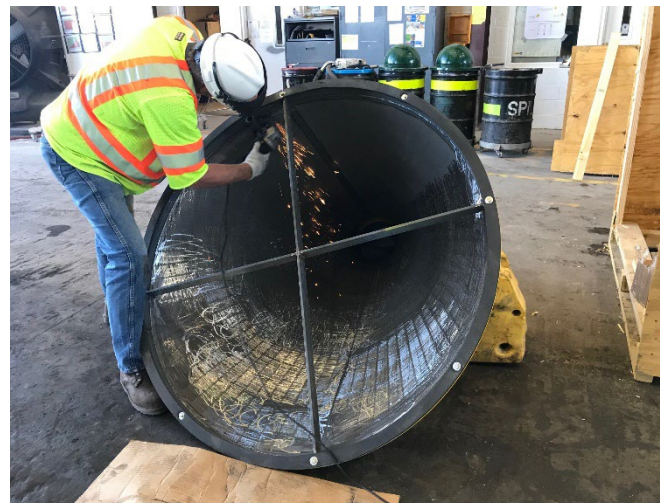
Surface preparation of gold mine drill cone

- To begin the application process, the drill cone component facing abrasive wear was removed from the drill.
- For adequate surface preparation, the inside surface of the cone was roughened with an abrasive disc pad until the white metal was revealed.
- Devcon DFense Blok hardener was easily mixed with the resin using an in-house mixer to ensure homogeneity.
- Devcon DFense Blok was then applied by hand to the prepared surface of the drill cone using a trowel.

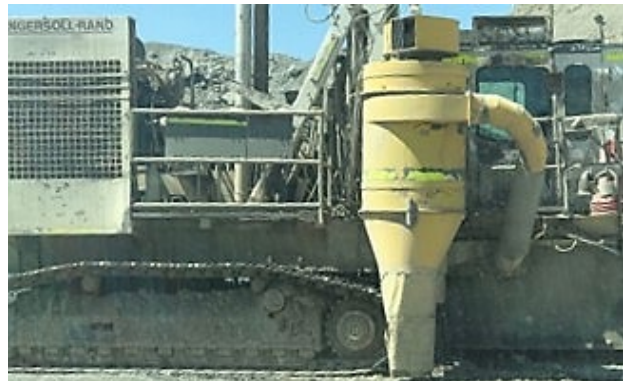
Gold mine drill

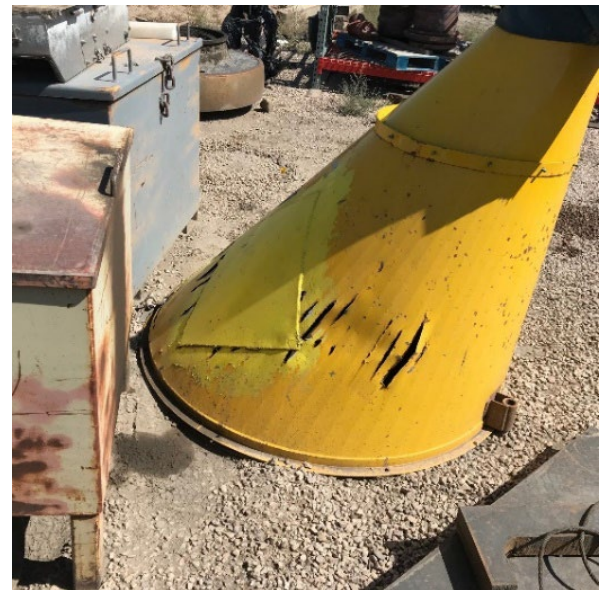
Steel AR plate tack welding to drill cone

Prior repairs included tack welding steel AR plates to the outside surface of the drill cone. By hiring outside personnel, this process can become particularly expensive. With Devcon DFense Blok, the epoxy coating was easily applied by plant maintenance staff, effectively reducing the overall repair costs of the drill cone.
