Flooring Quickly Rebuilt with Devcon® Floor Patch™ Resurfacer in Just Two Hours

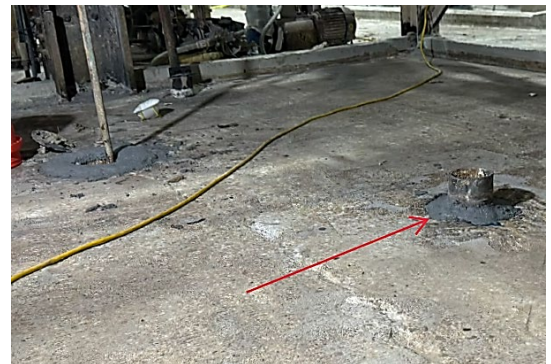
Devcon Floor Patch used around floor penetrations before pouring Devcon Floor Resurfacer

- **Installation Speed:** After the damaged floor was removed, the product was applied quickly and efficiently. In this case, 636 ft² (59 m²) of flooring was successfully installed in just two hours.
- **Curing Time:** Devcon Floor Patch Resurfacer has a robust room temperature cure time. While specific curing times may vary, it generally achieves full cure within 24 hours of application.
