Devcon Wear Guard® Fine Load™ Combats Steel Slag Abrasive Wear

Problem:

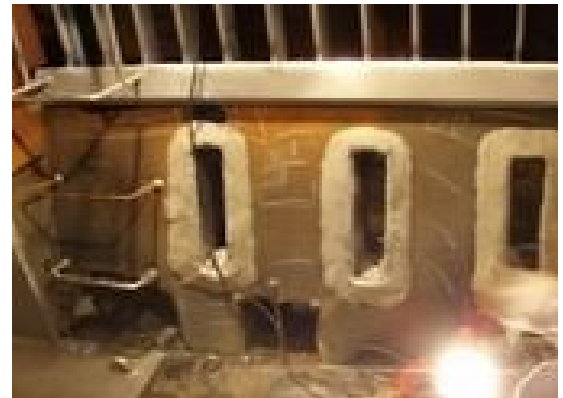
The abrasive and viscous steel slag had caused wear to the bottom half of discharge chutes, drain surfaces, and inlets. Being that both the drain and chute are fixed equipment, the client was looking for a repair solution that could be installed in-situ, to avoid a complex replacement installation.

Damaged drain face

- In order to complete installation of Devcon Wear Guard Fine Load, both the drain and chute were emptied of remaining steel slag.
- Metal areas of both equipment pieces were abraded using an abrasive disc pad, to ensure adhesion between the substrate and Devcon Wear Guard Fine Load.
- The industrial strength epoxy coating was then mixed and applied to the equipment via spatula.
- Devcon Wear Guard Fine Load was easily applied to the vertical surface components of the drain inlets and chute duct.

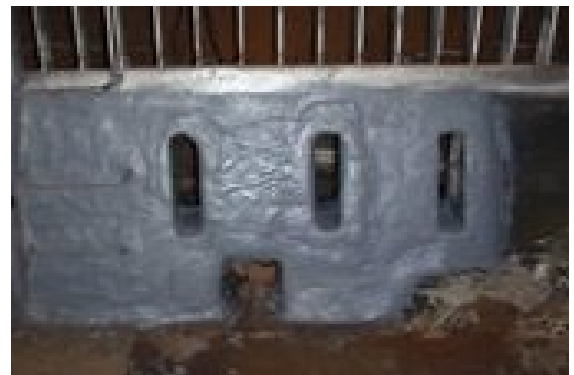
Drain face coated with Devcon Wear Guard Fine Load

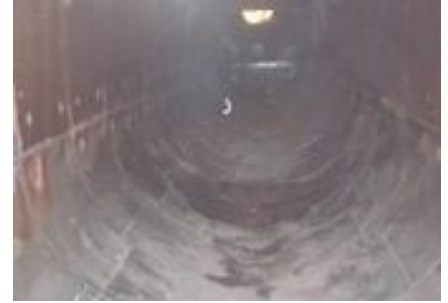
Damaged chute

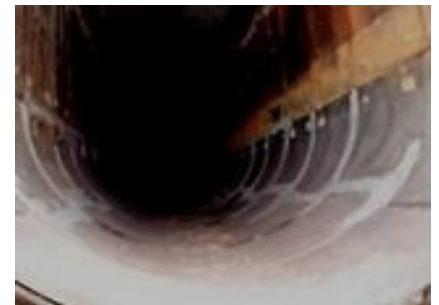
Chute coated with Devcon Wear Guard Fine Load
